PREMATURE FAILURE ANALYSIS OF SINGLE ROW, DEEP GROOVE BEARINGS FROM IDLER ROLLERS USED ON MINE SITES

November, 7 2016

ENGG411 - Engineering Research Thesis	Final Report
2	Patrick O'Farrell - 43273246

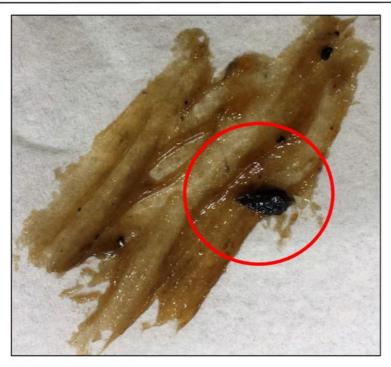
Figure 65: Bearing 1.1 lubrication

This bearing rotated freely while lubrication was still sufficient with no apparent problems. There was minimal visible debris with the lubrication as depicted above in figure 65, with overflowing/leaking grease in a few areas. Although this could have occurred after disassembly. Spreading some of the grease out on a paper towel it was possible to detect some black particles (the polymer used for bearing housing) and a few silver particles believed to be from the balls or the races of the bearing inside.

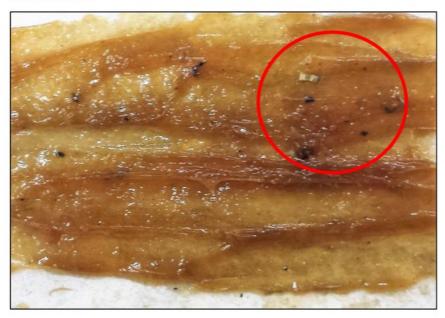
Figure 85: Bearing 3.2 lubrication

Bearing 3.2 also had a lack of lubricant as with 3.1 and had multiple large black polymer particles common throughout the grease. The lubricant had leaked out to the edges bringing with it small metal flakes and small black particles. The bearing rotates freely but grinding/crunching was audible at various points around the bearing.

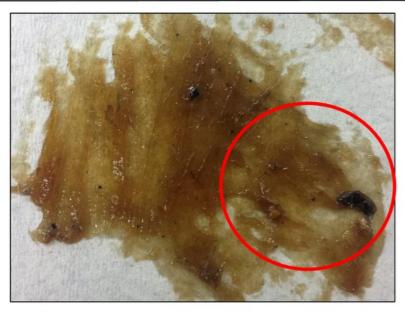
Figure 100: Bearing 5.2 lubrication

There was a lack of lubricant in bearing 5.2 for roughly one quarter of the bearing and was chunky, as if stuck together in clumps. It rotated smoothly with no audible crunching or grinding and very few polymer debris nor were metal particles visible. However, the debris found was predominantly on the larger side.

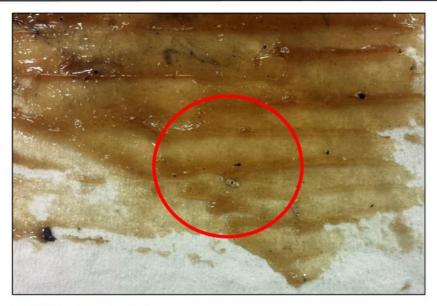
Figure 106: Bearing 6.1 lubrication

Bearing 6.1 also rotated smoothly while grease was still contained, albeit roughly 60% of lubricant remaining. There were 2 long thin strands of metal (7 mm long and much less than a fifth of a millimetre in diameter) on the edges of the outer rings race. As with the previous bearings the same small and large polymer particles and small metal particles were found within the grease.

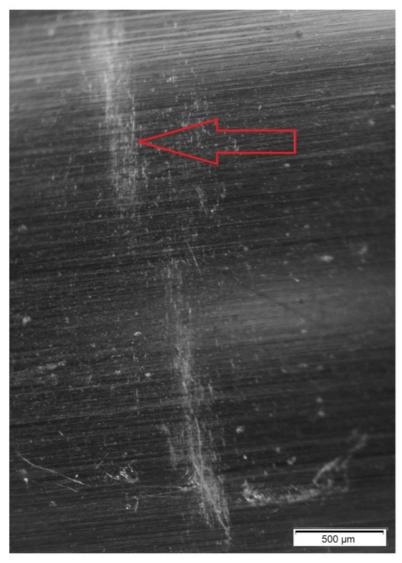
Figure 113: Bearing 1.1 outer ring scratches

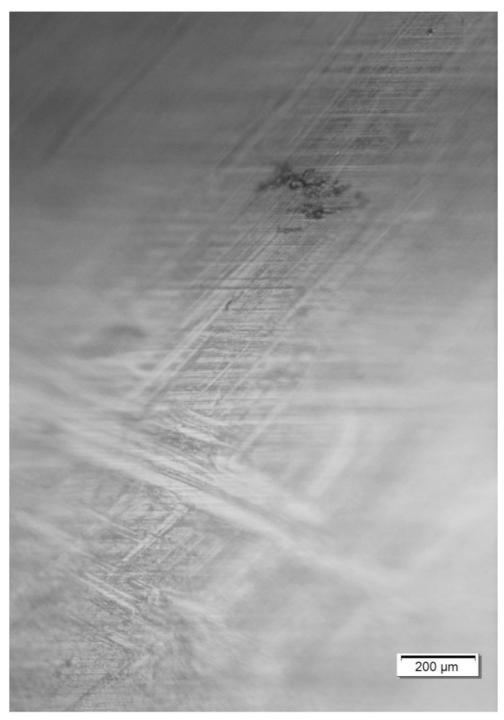
Figure 114: Bearing 2.1 outer race scratches

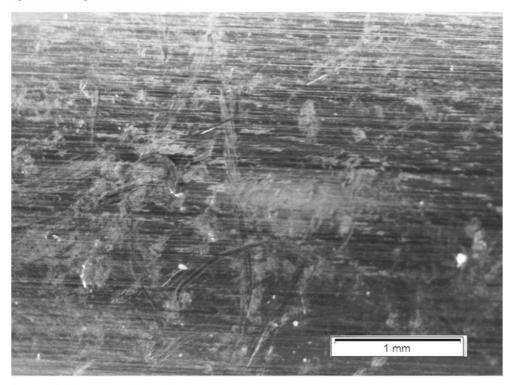
Figure 123: Bearing 6.1 outer race scratches

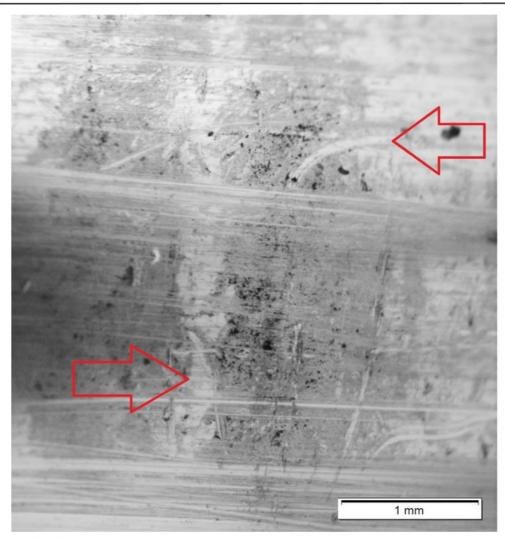
Figure 124: Bearing 6.1 outer race scratches

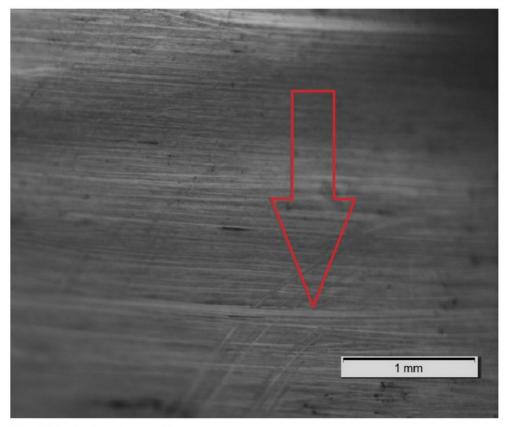
Figure 125: Bearing 6.2 outer race scratches

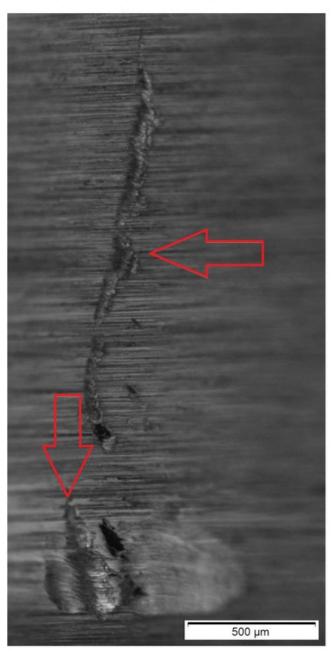
Figure 126: Bearing 1.1 inner race edge

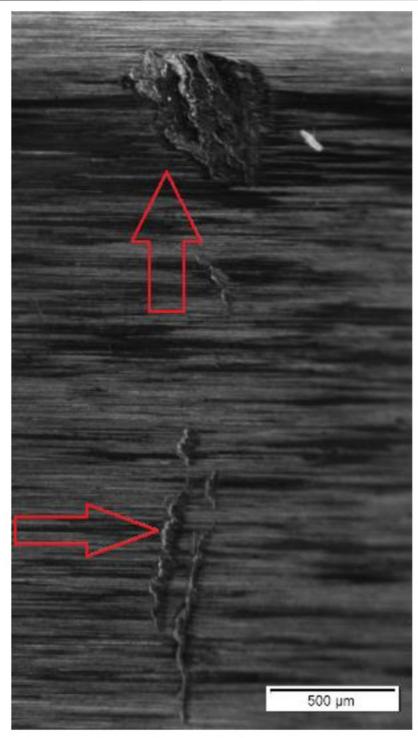
Gouges and deep scratches are the result of three body abrasion and are the next stage on from surface scratches. These were also found on the inner and outer races of multiple bearings in multiple places, making them relatively common.

Figure 127: Bearing 2.1 outer race gouges near edge of race

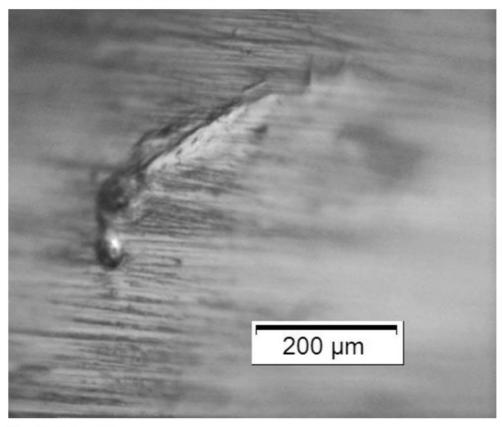
Figure 132: Bearing 6.1 outer race gouge

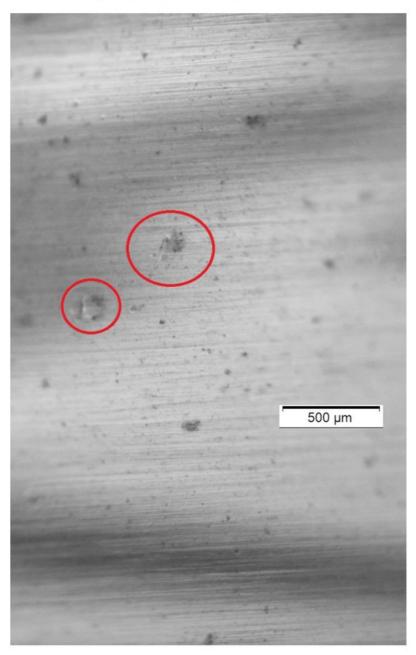
Figure 136: Bearing 1.1 inner ring pitting

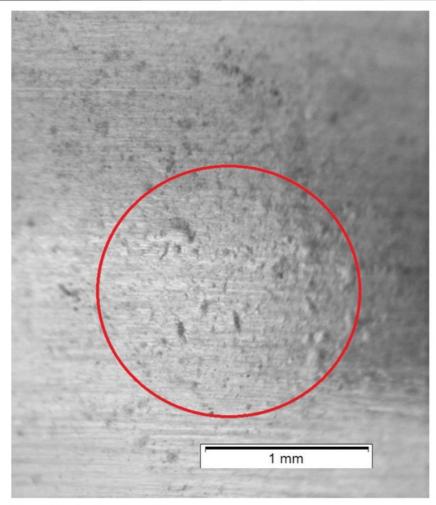
Figure 139: Bearing 4.2 outer race pitting

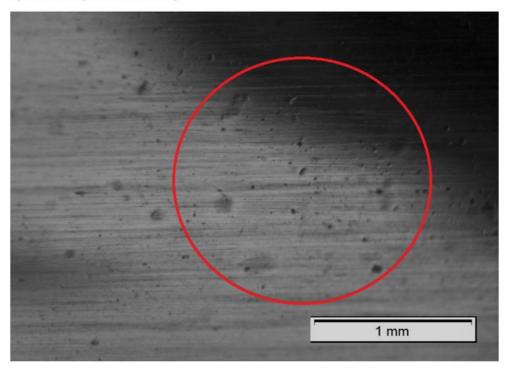
Figure 142: Bearing 6.2 inner race pitting and bruising

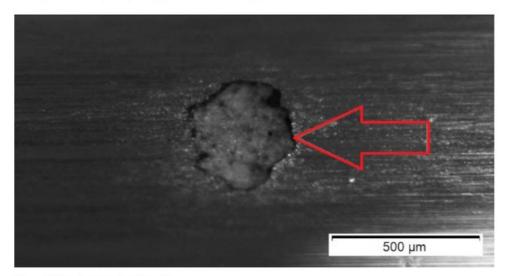
Figure 143: Bearing 1.1 outer ring spalling

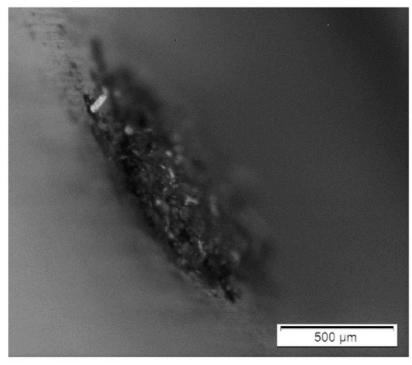
Figure 144: Bearing 2.1 inner race spalling

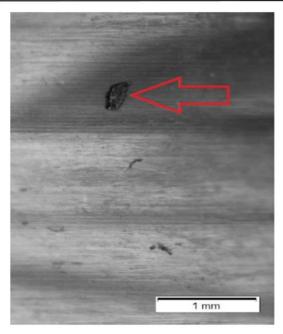
Figure 145: Bearing 3.2 inner race spalling

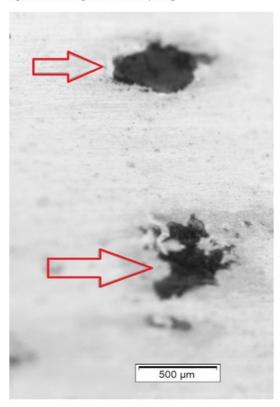
Figure 146: Bearing 4.1 inner race spalling

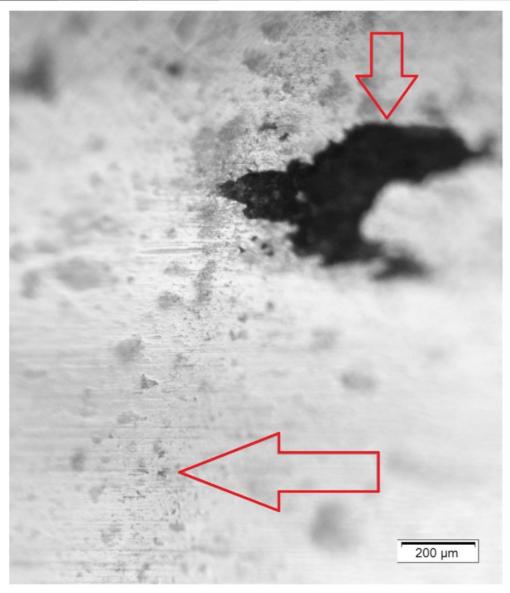
Figure 147: Bearing 4.2 inner race PSO spalling

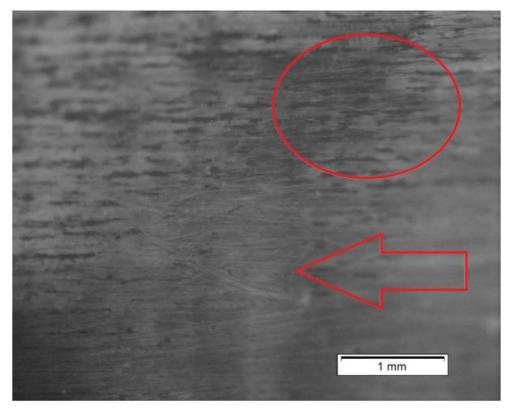
Figure 152: Bearing 5.2 inner race surface contamination

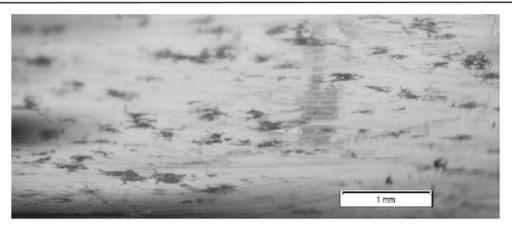
Figure 153: Bearing 6.1 outer race surface contamination

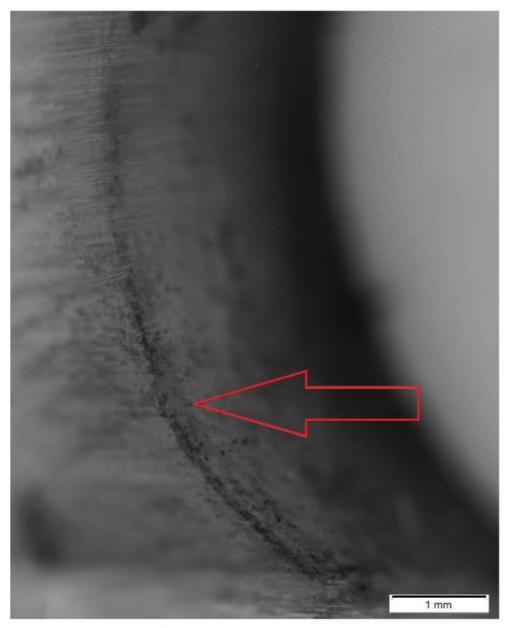
Corrosion or etching is explained under "Bearing Damage Analysis" -> "Wear" -> "Corrosion/Etching" and is where contaminants as water penetrate the bearing, wearing away the surface and increasing friction due to the uneven surface. It can be identified by wear patterns shown in figure 154.

Figure 154: Bearing 2.2 inner race corrosion/etching

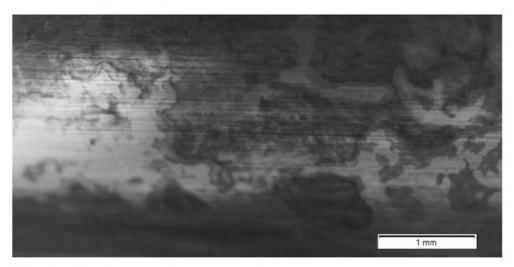
Heat Damage is the result of high friction due to various reasons explained in detail later such as lubrication breakdown, imperfect surfaces from pitting or corrosion. The surface is usually discoloured as depicted in figure 155.

Figure 155: Bearing 4.1 outer race surface breakdown due to heat

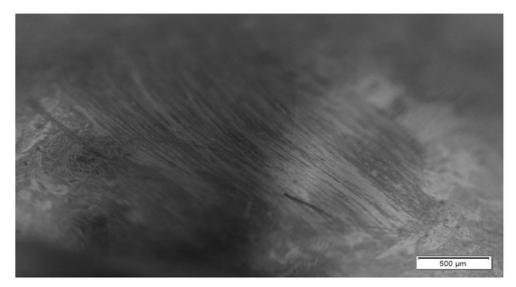
Figure 156: Bearing 1.1 ball surface scratches

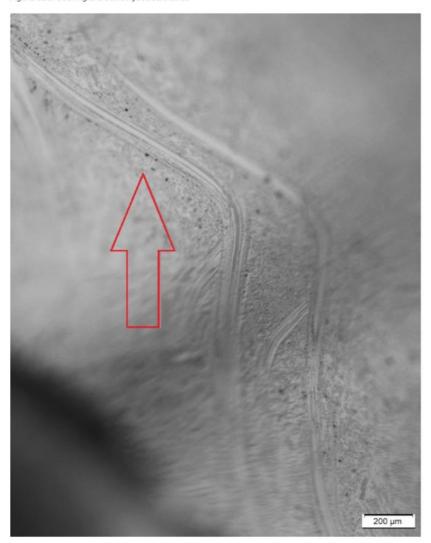
Figure 159: Bearing 3.2 ball scratches

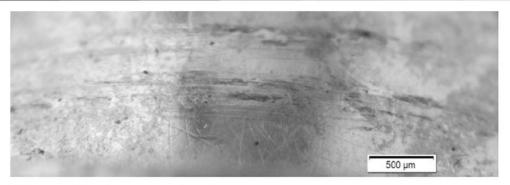
Figure 160: Bearing 4.1 ball surface scratches and wear

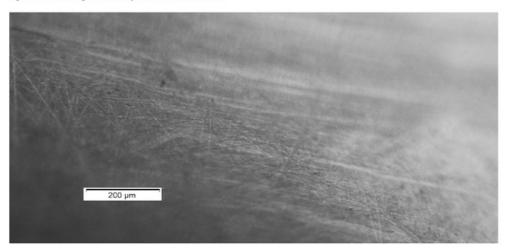
Figure 161: Bearing 5.1 ball scratches

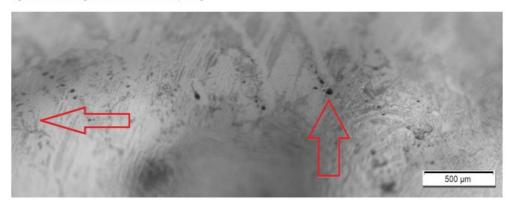
Figure 166: Bearing 3.2 ball pitting with surface wear

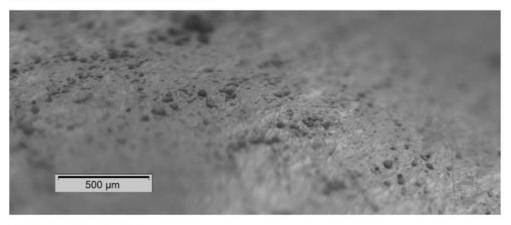
Figure 167: Bearing 4.2 ball pitting

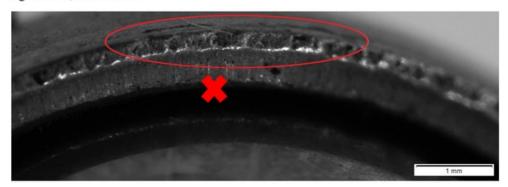
Figure 168: Bearing 1.1 cage edge wear

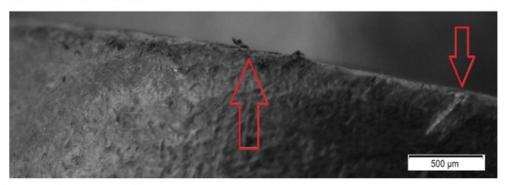
Figure 169: Bearing 3.1 cage edge wear

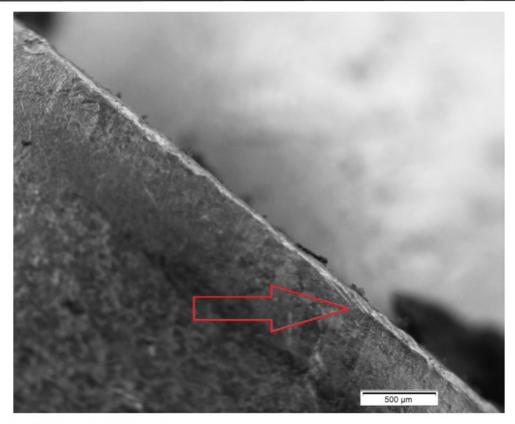
Figure 171: Bearing 4.2 melted cage edge and wear

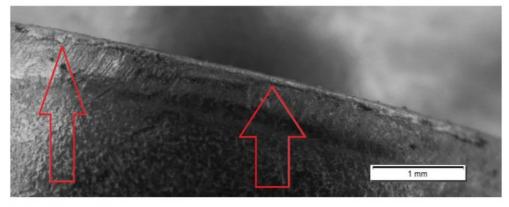
Figure 172: Bearing 5.1 melted cage edge and wear

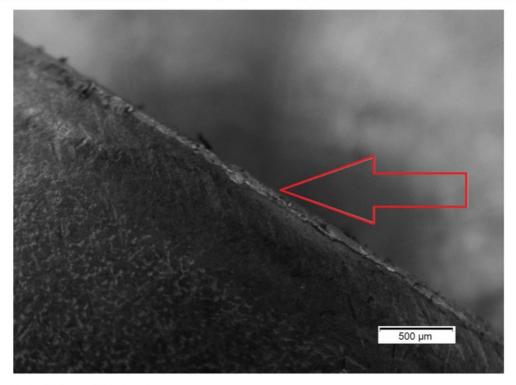
Figure 173: Bearing 5.2 cage edge wear

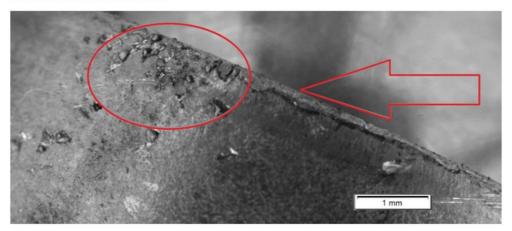
Figure 174: Bearing 6.1 cage edge wear

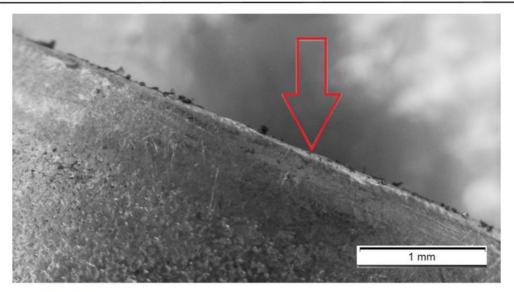
Figure 175: Bearing 6.2 cage wear
