**CONDENSATION INVESTIGATION**  
**AT THE NATIONAL GALLERY OF AUSTRALIA OFF-SITE FACILITY**

Bachelor of Engineering  
Mechanical Engineering

Department of Mechanical Engineering  
Macquarie University

November 7th, 2016

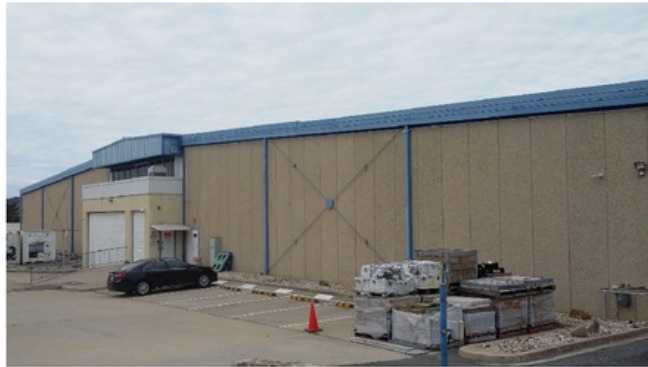
**Figure 4.1.** External façade of the NGA off-site facility.

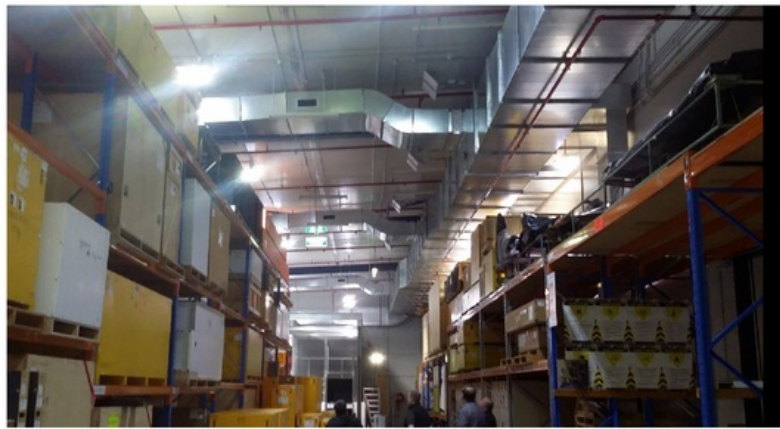
The concept of “box in a box” is applied to provide an internal space adequate for the purpose of art conservation and storage. The materials used for this purpose are mentioned below:

**Figure 4.2.** Internal overview of the NGA off-site facility.

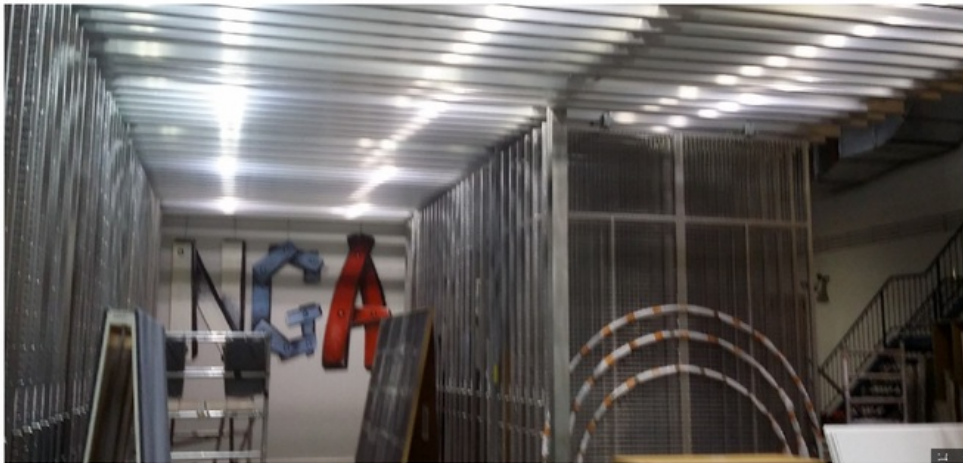
**Figure 4.3.** Rack structure within the NGA off-site facility

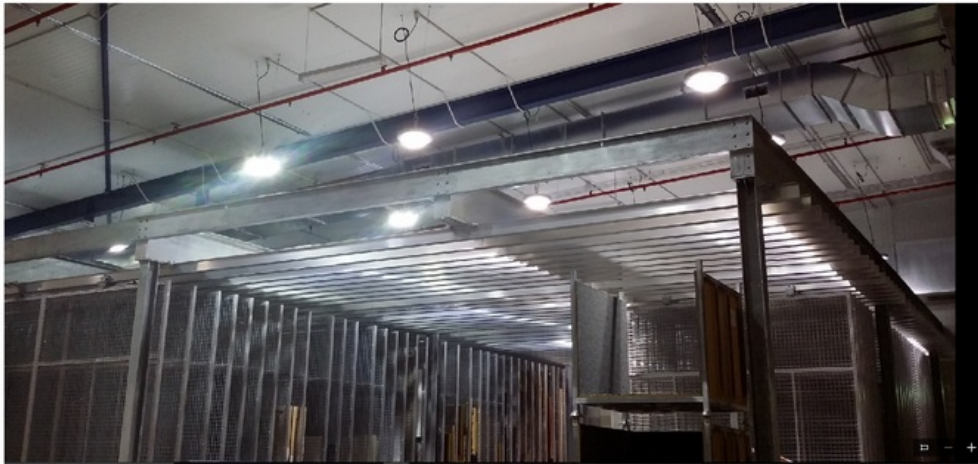
**Figure 4.4.** Rack structure within the NGA off-site facility

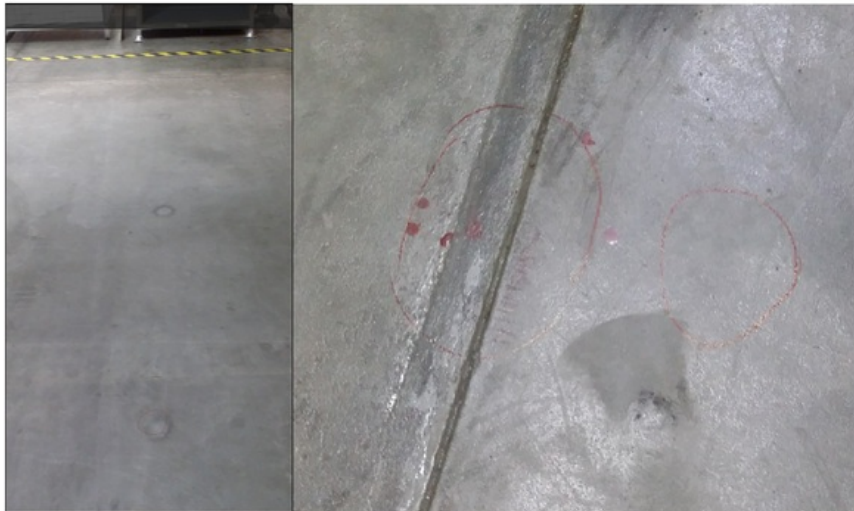
The problem of condensation has been addressed through documentation, personnel survey and visual evidence as shown in figure 4.5.

**Figure 4.5.** Condensation marks on the floor marked by personnel.

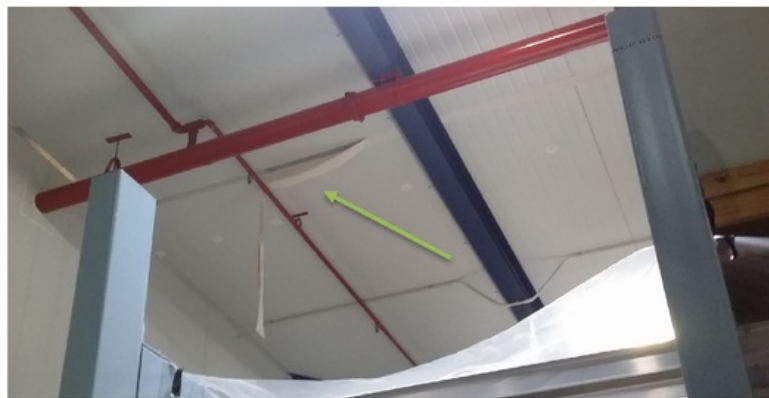
**Figure 4.7.** Detachment of vapour seal tape 2 in the ceiling panel joint.

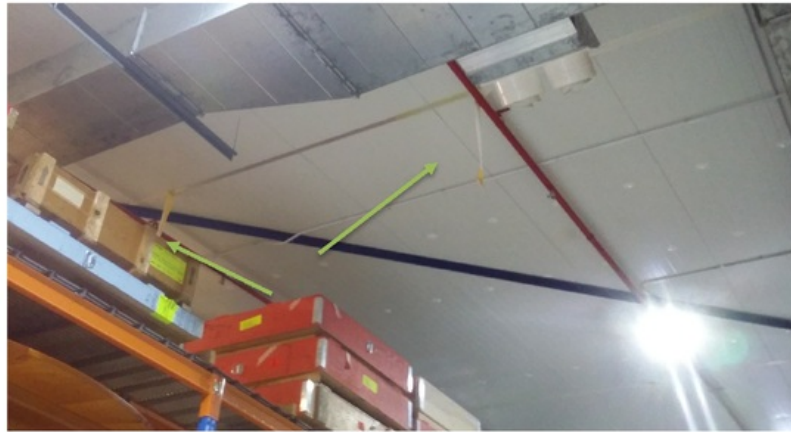
**Figure 4.8.** Detachment of vapour seal tape 3 in the ceiling panel joint.

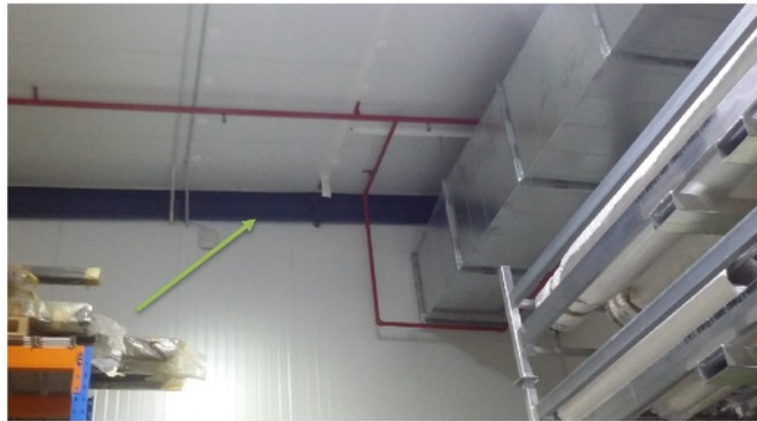
**Figure 4.9.** Detachment of vapour seal tape 4 in the ceiling panel joint.

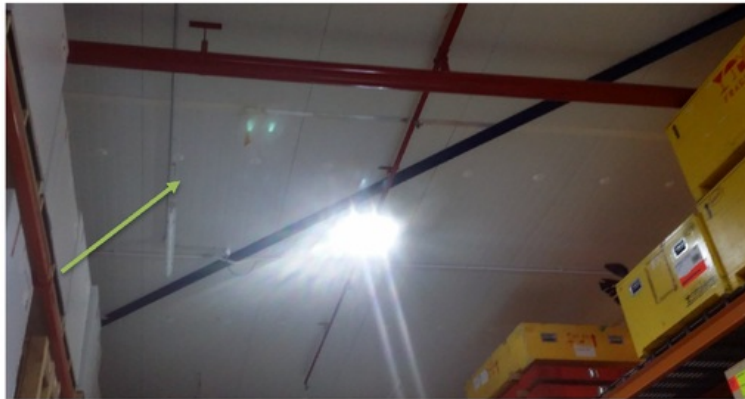
**Figure 4.10.** Detachment of vapour seal tape 5 in the ceiling panel joint.

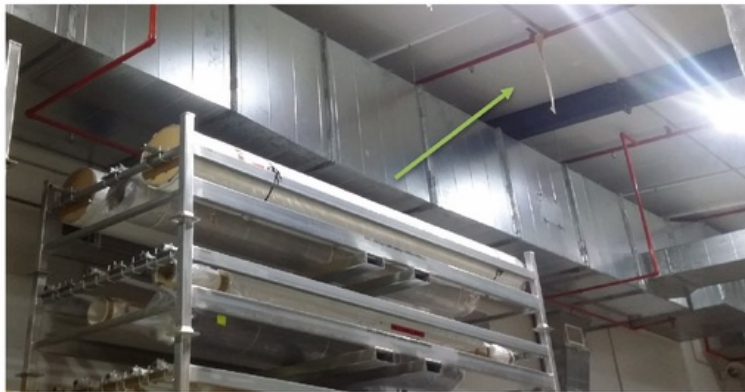
**Figure 4.11.** Detachment of vapour seal tape 6 in the ceiling panel joint.

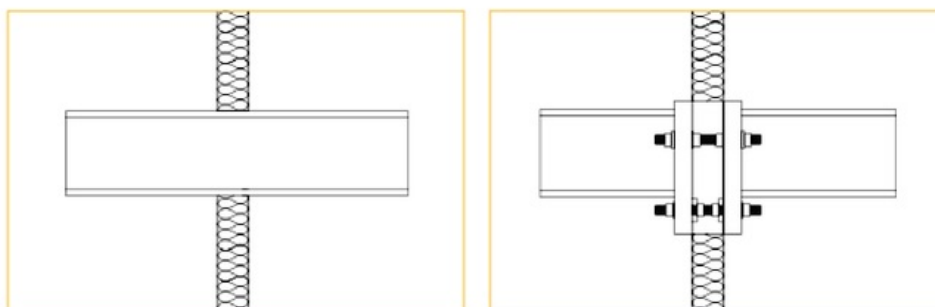
Figure D.2. Structural Attachment [40].
