Diagnosis of a base metal mine tailings capping failure

This 9 month thesis was submitted in accordance with the requirements of the Master of Research

Department of Environmental Sciences

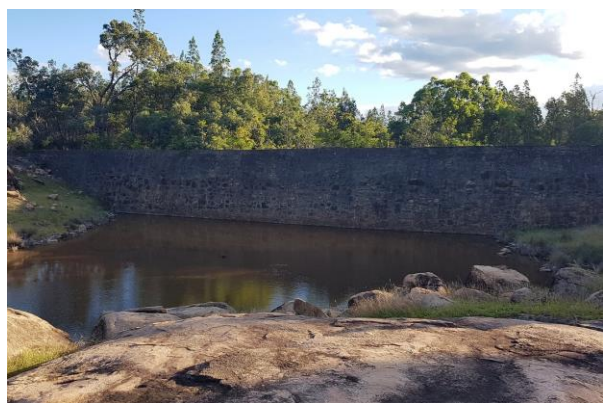
Fig 3: Water supply dam above the worked site at Howell (29°56'53.15" S 151°1'56.35" E).

The reference site has had limited disturbance relative to the rest of the study area and remains mostly in a natural condition. However it does contain the entry/haul road and existing infrastructure of the former Howell township. A former water supply dam on Borah Creek (**Figs 3, 4**), that has three residential properties in its catchment, forms the upstream extent of this report. The haul road crosses Borah Creek downstream of the dam and immediately downhill of a locked gate (29°57'5.47" S 151°1'42.25" E). Borah Creek is in a mostly natural state throughout Site 1 (**Fig 5**).

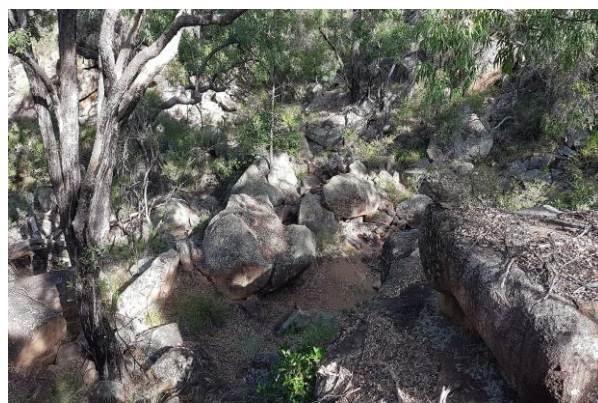
Fig 4: Borah Creek within Site 1 with extensive in-channel and riparian vegetation (29°57'10.62" S 151°1'32.95" E).

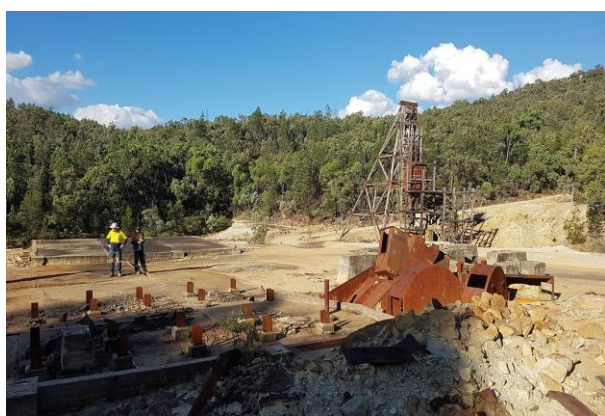
Fig 5: Ore processing and smelting infrastructure at the Conrad shaft (29°57'16.66'' S 151°1'26.21'' E).

The dominant feature is the headframe (poppet head) over Conrad shaft (**Fig 5**) and the surrounding processing and smelting infrastructure to the south of the haul road. North of the haul road there are two concrete slabs, one at ground level west of the headframe and another supported by pillars north of the headframe, which supported massive winding engines for trucks hauling ore up the shaft. A small intact dam west of the UT (**Fig 6**) spills northward to the processing area.

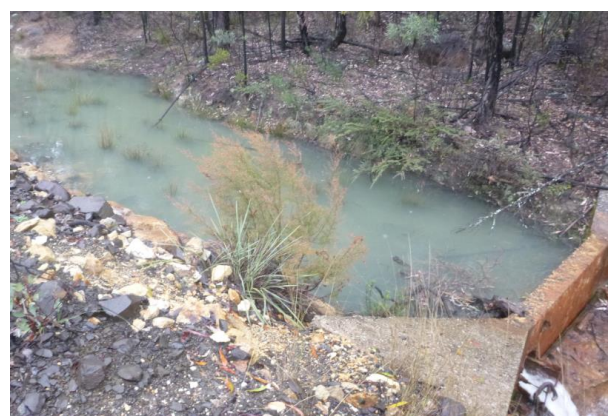
Fig 6: The small dam immediately west of the UT (29°57'21.15'' S 151°1'26.67'' E).

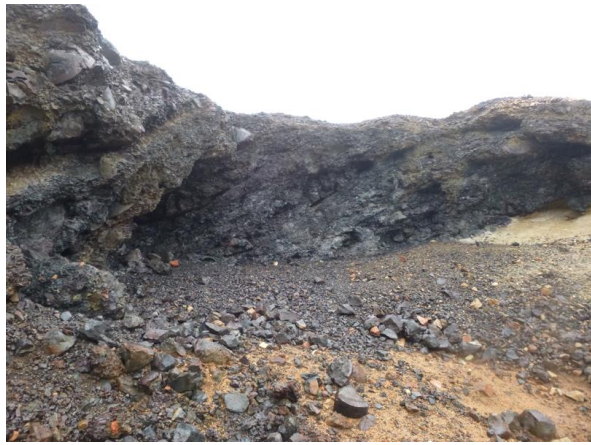
Fig 7: Multiple generations of slag and waste rock (29°57'16.45'' S 151°1'27.85'' E)

South of the haul road, multiple slag heaps (**Fig 7**) contain different textures, indicating successive generations of smelting. These slag heaps are top dressed with waste rock, as is the haul road (**Fig 8**), processing area, and creek bed (**Fig 9**). Waste rock heaps are piled against the hillslope east - southeast of the headframe and on the southern bank of Borah Creek. Fines from processing and smelting remain around remaining infrastructure at the processing area where the ground is protected from rainfall.

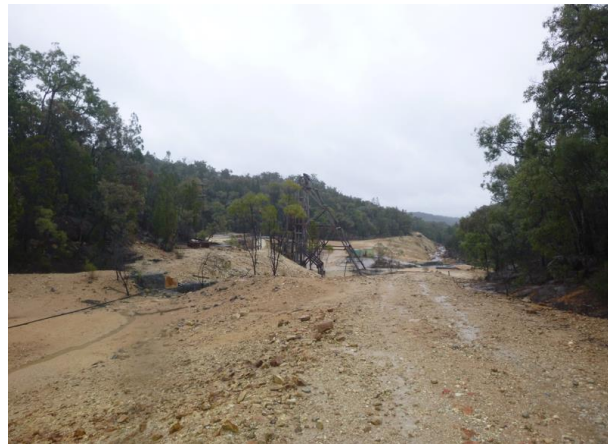
Fig 8: Haul road top dressed with waste rock (29°57'17.98'' S 151°1'33.16'' E).

The use of mine waste as part of the materials for the diversion and battering of Borah Creek (**Fig 9**) as well as contour banking around the mine (**Fig 8**), has created a new source of contaminated material for fluvial transport (Gore et al. 2007). Much of the fine material used in this work has been eroded and transported, choking downstream sections of Borah Creek with contaminated sediment (**Fig 20, 21**). Some of this sediment has been transported through to Copeton Reservoir, where it exceeds the ANZECC guidelines (**Fig 35**). Further use of potentially contaminated mine waste material in rehabilitation works should be halted. Elemental analyses should also be conducted on any potentially contaminated material before use in rehabilitation works.

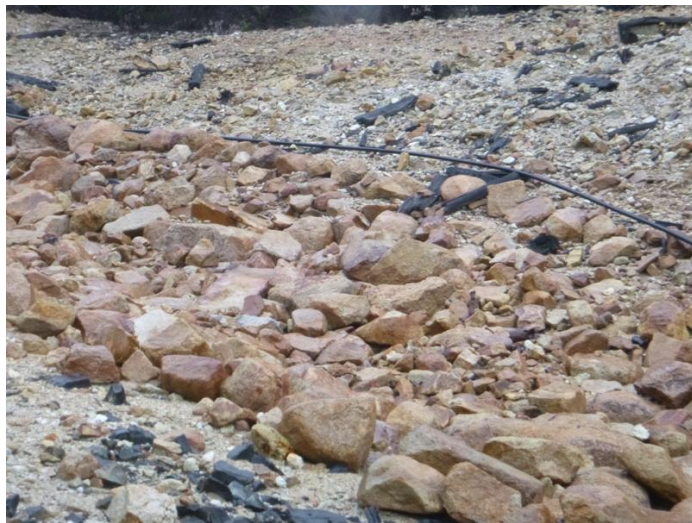
Fig 9: Creek bed lined with waste rock. All fine material has been transported downstream (29°57'17.32'' S 151°1'31.62'' E).

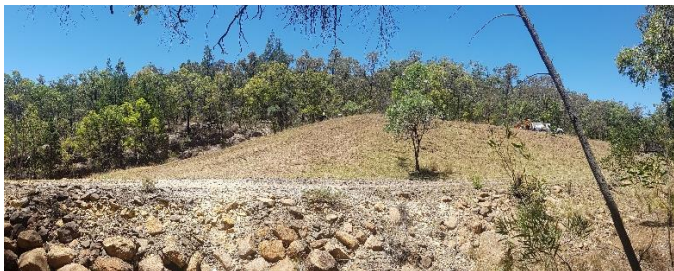
Rehabilitation work at Site 2 included tailing capping and drainage line modification. At the time of works in March 2017, January 2018, and October 2018, the UT capping was well vegetated (**Fig 10**), however the thick iron precipitate in the overflowing sediment trap below the structure indicates that the tailings capping is ineffective (**Fig 11**). This ARD precipitate continues down the drainage line (**Fig 12**) until level with the haul road. Extensive drainage lines and contour banks have been formed to redirect flow around the processing area and these are still intact, however they are formed from waste rock and most of the fine materials have been transported downstream (**Figs 9, 13**). The basalt gabions inhibit any potential knickpoint retreat (**Figs 2, 14**).

Fig 10: The western side of the capped and vegetated UT. (29°57'20.69" S 151°1'28.04" E).

Zn and As levels rise sharply downstream of where drainage from the UT intersects Borah Creek (**Fig 44**), despite the capping and sediment trap constructed at the base of the structure (**Figs 10, 11, 12**).

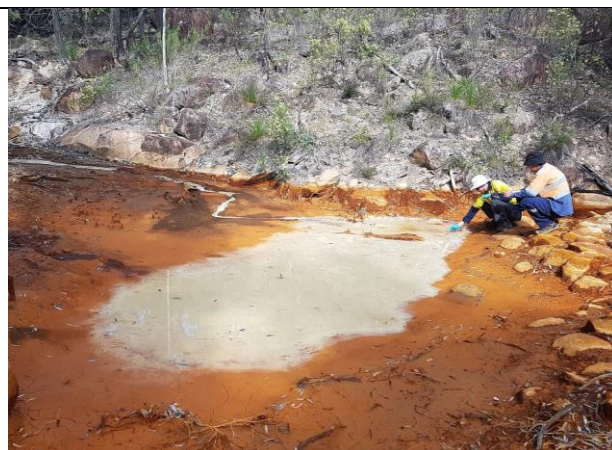
Fig 11: Precipitates in the sediment trap below the UT (29°57'20.69" S 151°1'28.04" E).

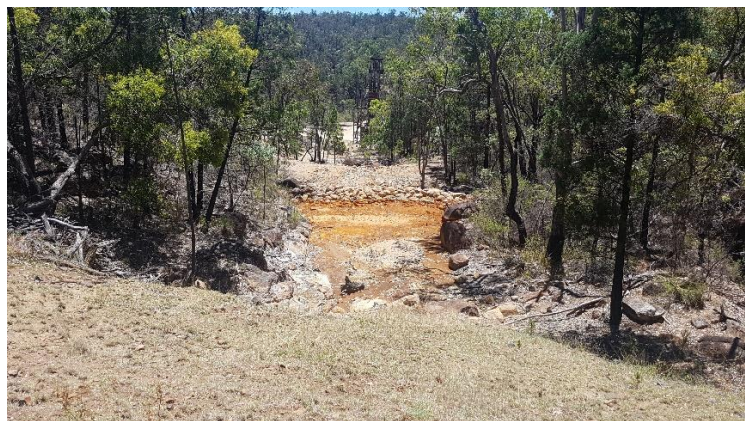
Fig 12: Looking north from the UT, down the drainage line to Conrad shaft (29°57'18.08" S 151°1'28.63" E).

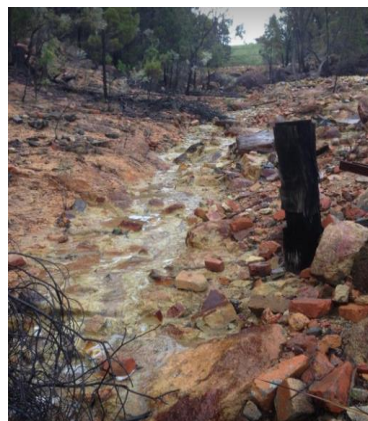
Fig 13: Acid mine drainage and extensive precipitation from the UT (29°57'18.08" S 151°1'28.63" E).

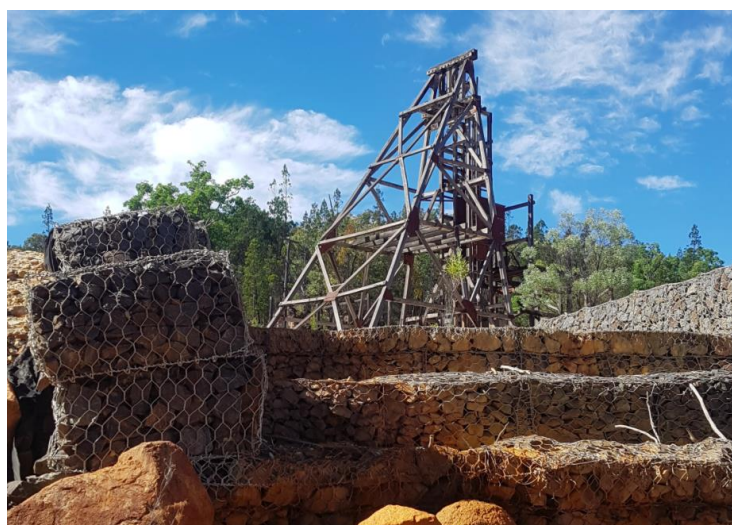
Fig 14: Basalt gabions preventing potential knickpoint retreat (29°57'18.08" S 151°1'28.63" E).

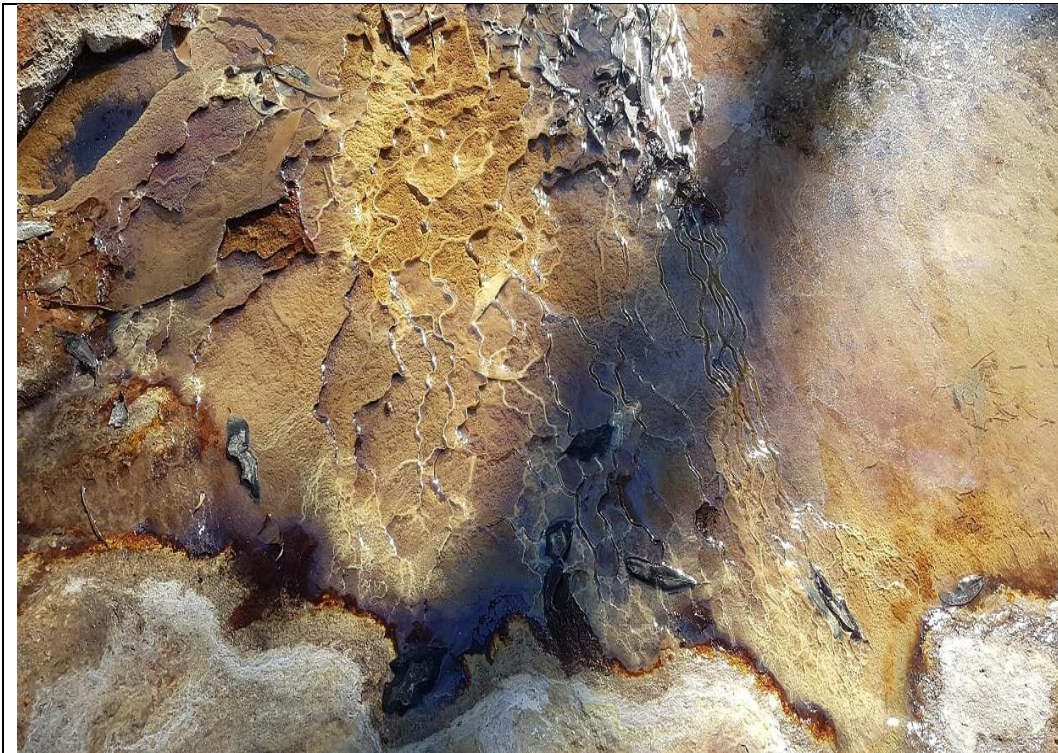
Fig 15: As-rich precipitate forming terracettes in the channel below Allwell shaft ($29^{\circ}7'1.82''$ S $151^{\circ}1'14.65''$ E). Image is ~1 m across.

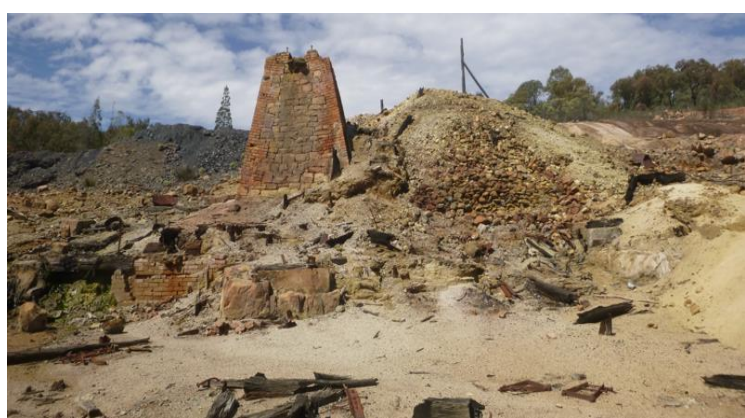
A Turkey's Nest dam, a large concrete lined square dam used for electrowinning Cu, located at the top of Site 4, contains a fine sediment covered with white efflorescence on the upper concrete and the soil downslope of the dam where leachates surface. Surrounding the dam and towards the former smelter works to the south are capped drill holes from exploration by Malachite Resources. The remains of the smelter stack lies amongst rubble of previously demolished infrastructure, including processing plants and skipway supports (**Fig 16**). Numerous salt efflorescences are present among the mixed processing wastes.

Fig 16: King Conrad processing and smelting ruins (29°57'1.39" S 151°1'9.09" E).

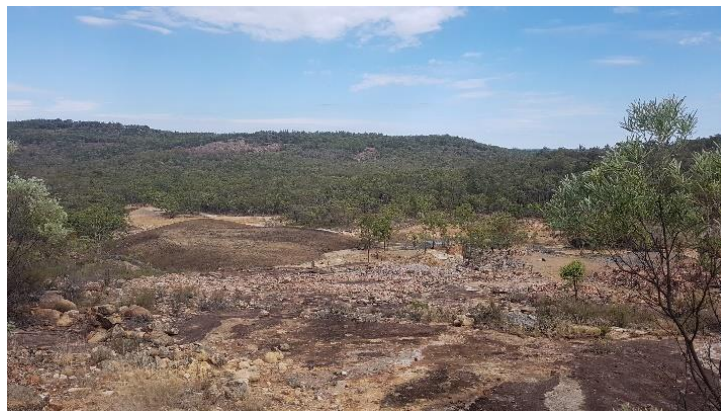
Fig 17: The recently capped LT (soil covered mound to the left of photograph) (29°57'0.32'' S 4151°1'4.36'' E).

The LT (**Figs 2, 17**) is the most recent tailings, which contains fines from processing as well as recent material from rehabilitation works in 2003. Multiple generations of material from different processes and locations are present in the LT and the drainage line contains significant efflorescence on rocks and a thick algal mat (**Fig 18**). Similar efflorescence and algal coverings occur in the drainage line of the large slag dump at the northern end of Site 4 (**Fig 2**). The large slag dump is physically stable as a consolidated mass, however smaller crushed slag dumps, coke, flue dust and waste rock distributed throughout the processing/smelting area are physically mobile (**Figs 2, 16**).

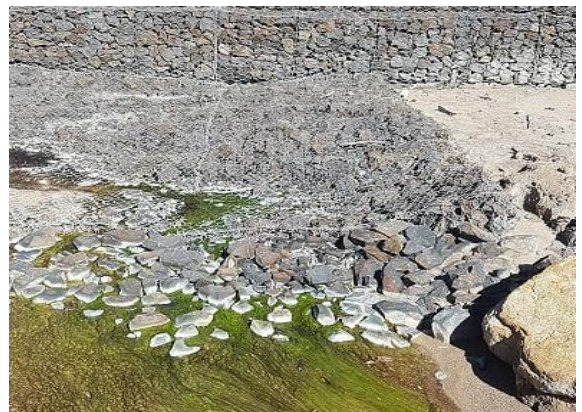
Fig 18: Efflorescence and algae amongst the discharge of the LT compound (29°57'1.99'' S 151°0'59.78'' E).

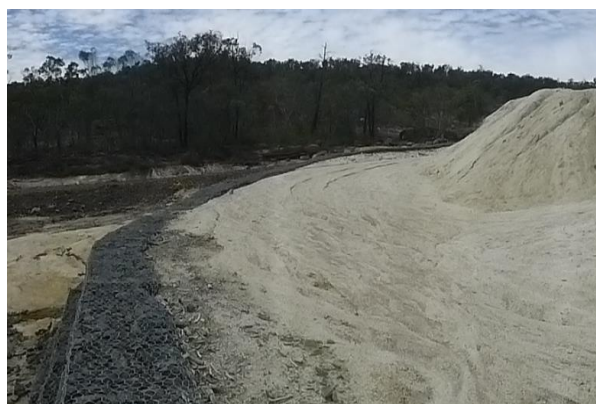
Fig 19: Transported tailings overtopping the containment of the LT before capping (29°57'2.82'' S 151°0'59.9'' E).

The LT (**Figs 2, 17, 19**) had been previously contained with basalt gabions to limit physical transport of tailings material, however deposition at the downslope end infilled against, and was overflowing the edge of the gabion (**Fig 19**). Fine grained material eroding from the LT, as well as the contour banks and exposed space north of the LT (**Fig 17**), has infilled the channel behind the lower gabions, limiting the base flow of Borah Creek to beneath the sediment (**Fig 20**). During 2018 the LT was contoured and capped (**Fig 17**), reducing the transport of mine waste offsite. The section of Borah Creek between the slag dump and LT which was realigned in the 2003 rehabilitation has incised the channel to bedrock and is actively widening.

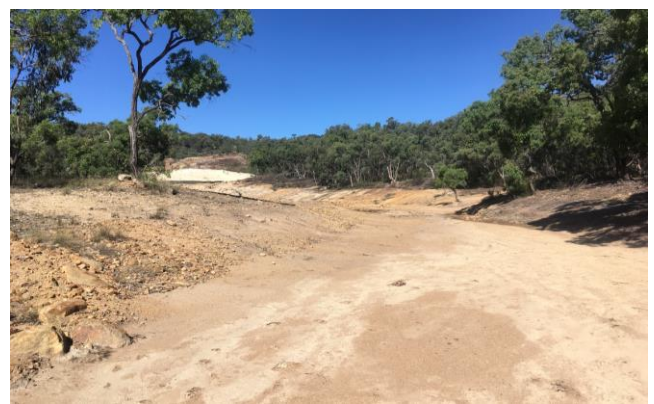
Fig 20: Water in Borah Creek enters subsurface flow due to the backfilling of fine grained permeable sediment in the channel upstream of the basalt gabions (29°57'3.32'' S 151°0'54.3'' E).

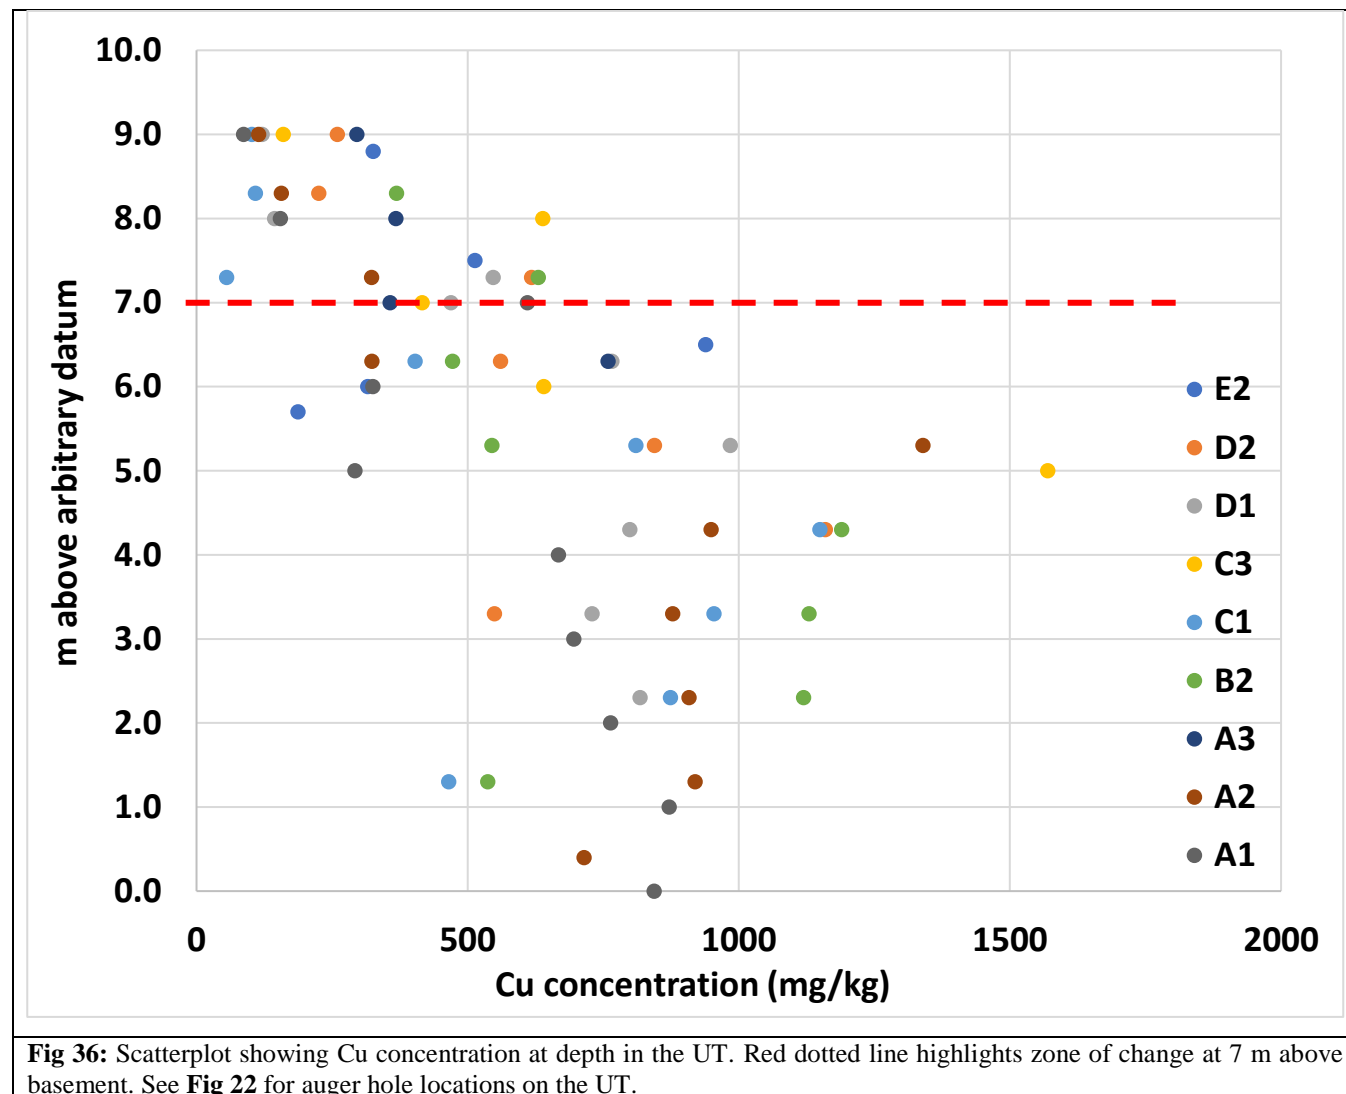
Fig 36: Scatterplot showing Cu concentration at depth in the UT. Red dotted line highlights zone of change at 7 m above basement. See **Fig 22** for auger hole locations on the UT.

Figures 36, 37, 38 and 39 break these data down further, showing individual sample concentrations with depth. There are two distinct zones within the UT, the margin between the two being ~7 m above basement depth. The upper zone has lower Cu, Zn, and Pb concentrations, but higher As. The lower zone has more variability, but is generally higher in Cu, Zn, and Pb while lower in As. There are also physical differences between the layers, with the upper layer being white in colour and dry, while the lower layer is moist and greyer (**Fig 40**).

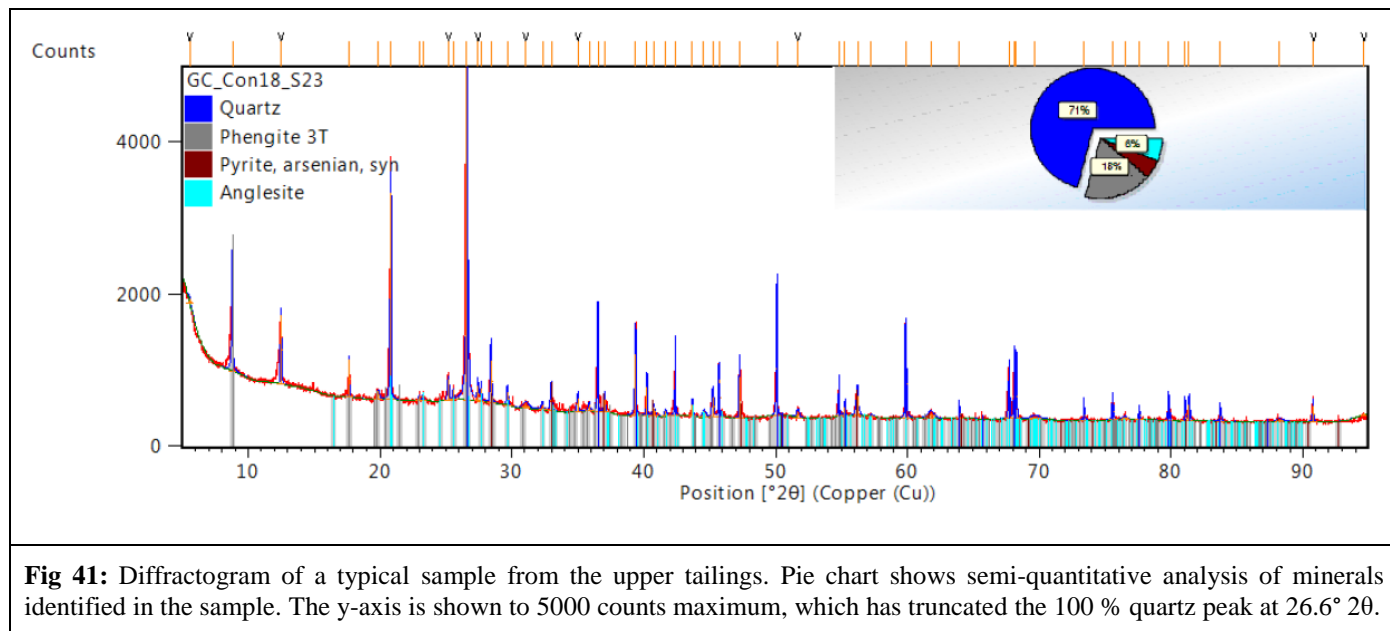
Figure 41 shows a diffractogram typical of those collected from UT samples. Samples consisted mostly of quartz according to the semi-quantitative analysis produced by the High Score Plus software, with metal(loid) bearing minerals making up a small percentage of the sample.
