PREMATURE FAILURE ANALYSIS OF SINGLE ROW, DEEP GROOVE BEARINGS FROM IDLER ROLLERS USED ON MINE SITES

November, 7 2016

ENGG411 - Engineering Research Thesis	Final Report
2	Patrick O'Farrell - 43273246

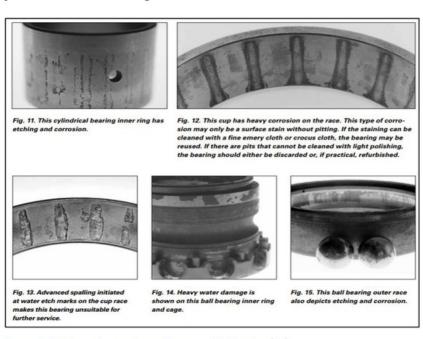
Figure 9: Etching and corrosion on the races of the bearing [13]

Corrosion, otherwise known as etching, is caused by water contaminating the internal surfaces of the bearings. It is most often caused by condensate collecting in the housing due to vast temperature ranges. Again, faulty or worn seals are the primary cause of moisture finding its way inside the bearing [13]. During servicing if the components are not washed and cleaned correctly then traces of water will be left inside the bearings, although in the case of a mine site it's not likely the bearings will be taken apart to that degree as they should be sealed for life. As the race or balls are worn away, the internal clearances increase, leading to increased vibrations followed by further wear and loss of preload.

Etching leaves uneven surfaces, resulting in unwanted movement of the internal components as well as increasing friction of the bearing. This leads to heat becoming a huge contributor to premature failure of bearings.

Corrosion or etching takes place when foreign, oxidising particles such as water sit inside the bearing and erode the surface away. There are varying degrees of severity ranging from surface stains to water spalling as shown in figure 9. Etching occurs at the contact points between the ball and race where the particles can aid wear, acting as a catalyst for two body abrasion and spalling.

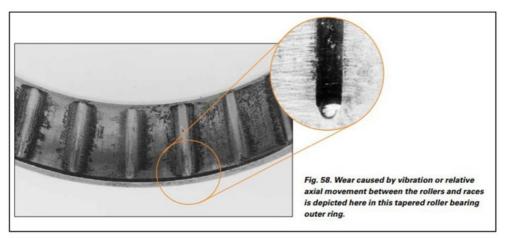
Figure 10: False Brinelling shown on the race

Another form of wear is False Brinelling, which is quite different to brinelling (which is explained later in this paper). Damage analysis may point to brinelling but on closer inspection, false brinelling is fretting wear. Its cause it small axial movement of the rolling elements while the bearing is stationary and a groove is worn into the race by the sliding roller due to vibrations. False brinelling wears away the surface of the material while true brinelling simple deforms it [13].

It can be detected by small bright marks on the race from where the rolling element has been rubbing off the surface finish. Without bearing movement the oil cannot access the contact point between the race and ball, permitting race wear to continue. This type of damage is disastrous when the wear debris oxidizes [14].

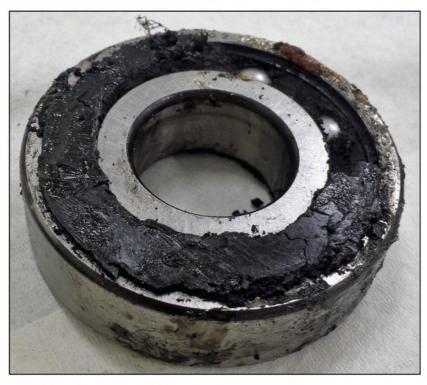
Figure 12: Total bearing seizure due to external bodies

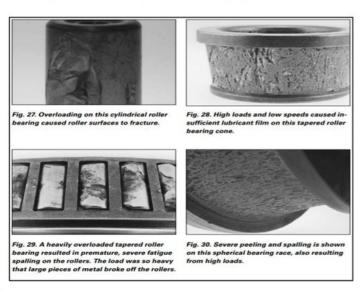
Excessive loading damage could be a result of tight fits between the internal components, extreme loads applied by the roller shell and material on top of the belt as well as excessive preloading. This is indicated by wearing on the race along the ball path as the ball appears to be heavy, continuously pressing into the race. The ball will become overloaded resulting in increasing temperature and torque, obviously resisting rotation. This can be avoided by lessening the load, redesigned bearings or a bearing with a higher load capacity [14].

Figure 13: Example of excessive loading on the races and rolling elements [13]

The figure above displays large amounts of damage caused by the overloading of a bearing. The surface of the race is subjected to plastic deformation, becoming an uneven surface which the rolling elements roll across. Damage to this extent generates large amounts of friction and therefore heat. This heat then creates the damage as explained earlier in 'Overheating'.

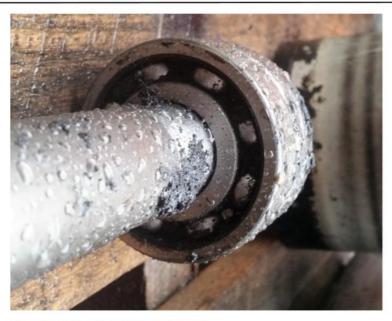
Figure 46: Internal side of the bearing on the shaft

From the last picture, it can be seen there are no seals as on the inner side of the bearing. This may be due to the inability for any debris to reach the inside of the bearing, or a mechanism for heat to be released. It is obvious that the polymer has penetrated the bearing from the inside.

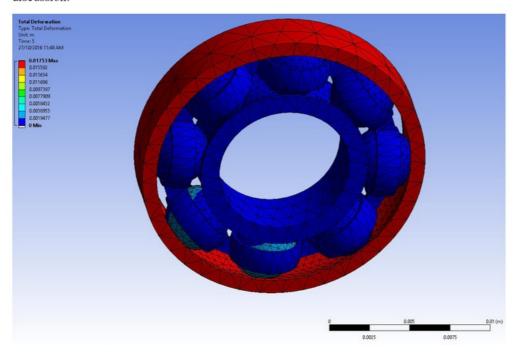
Figure 59: FEA Total Deformation of outer ring

Figure 59 above shows the total maximum deformation of the outer ring when subjected to bearing loads and rotation as stated in tables three and four respectively. The maximum load is 29,600 N and rotates to 200° over a period of five seconds. The maximum deformation of the outer ring is 0.0001753 meters.

In our case, the inner ring is stationary with the outside ring rotating with the roller (refer to figure 59. This means the load is applied to the outer rings face and rotates. When subjected to a bearing load of 29,600 N over a 200° rotation over five seconds, the total maximum deformation of the bearing is on the outer ring, with a value of 0.0001753 m. Considering the bearing is rotating at the time of applied load, the deformation is spread out over the entire area of the outer ring, In millimetres this is 0.1753 mm, a miniscule deformity. Judging from these results it can be shown that, as the total deformation is minimal, the bearing design is unrelated to the causes of premature failure.

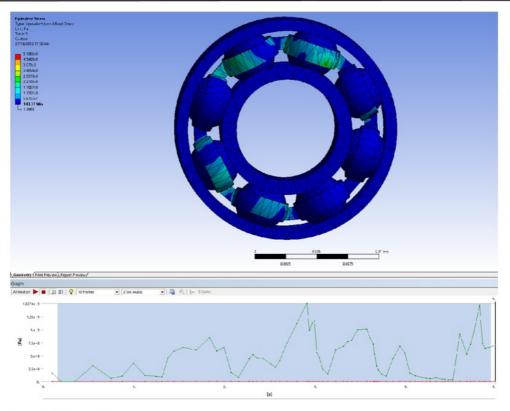
Figure 60: Equivalent stresses in a bearing

Equivalent stresses as shown above in figure 60 is a use of Von Mises stress which dictates when a material should fail due to high loads and stresses. It is measured in Pascals with the maximum stress reaching 510.82 MPa (mega Pascals) after approximately 2.9 seconds at the inner edge of the cage. The graph above depicts the increasing and decreasing levels of stress as the bearing load increases and the bearing rotates. This can be seen in figure 61 below with a high point of stress (highlighted red) on the inside edge of the cage next to the ball.

The stress subjected to the bearing is measured using Von Mises stress which helps dictate when a material will fail due to high loads and stresses. It is measured in Pascals with the maximum stress of 510.82 MPa occurring on the inner edge of the cage as shown in figure 60. Basically, this means that this point will be the first to fail, undergoing elastic then plastic deformation. We can see from the graph in figure 60 the increasing and decreasing stresses as the bearing rotates. As the modulus of elasticity is 210 GPa (table 2) we can observe the stresses subjected to the bearing are 0.2432% of the maximum value before plastic deformation. This verifies that the bearing has zero problem with the stresses and is unrelated to the premature failure of the bearing.

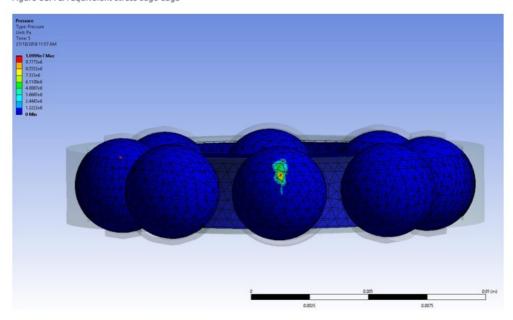
Figure 62: FEA pressure points on rolling elements

Figure 62 above also displays a reading in Pascals, in the form of pressure. The high point of pressure on the centre ball is applied by the bearing load and is transferred through the outer race to the ball. This is also after a period of five seconds and reaches a a maximum value of 10.999 MPa.

Figure 62 displays the pressures on the rolling elements (balls) and cage. While this does not validate any hypothesis, it is useful to detect the point on the balls that are subjected the highest amount of load and stresses. It is unusual that the point of highest pressure, 10.999 MPa is not directly in the centre of the balls axis (in terms of z axis, up). This could be due to the location of the coordinate system the bearing load is applied on or because the balls are free to rotate. However, this result is not significant to whether the bearing design is flawed, although is useful when examining the race and balls under a microscope to detect whether there is a pattern. It is possible more wear will occur along that plane on the race. The same cannot be said of the balls as they are free to rotate so even wear should be observed.

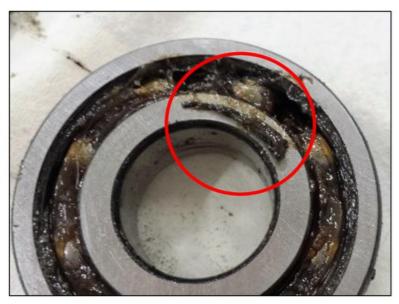
Figure 64: Bearing 1.1

Figures 64, 68, 72, 76, 81, 84, 94, 99, 105 and 109 show bearings 1.1, 1.2 to 6.2 respectively (excluding bearings 4.1 and 4.2). The interesting part they all have in common are foreign particles present in the bearing grease. As the grease is still present in the bearing, we can assume these particles would travel around the bearing as it rotated, increasing friction and damaging the balls, cage, inner race and outer race. The extent of this damage will be discussed later using micrographs under "Discussion" -> "Micrographs".

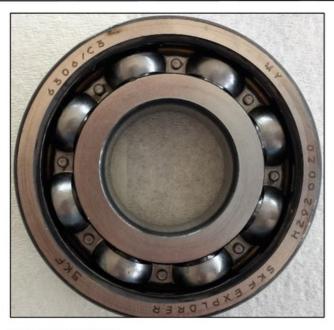
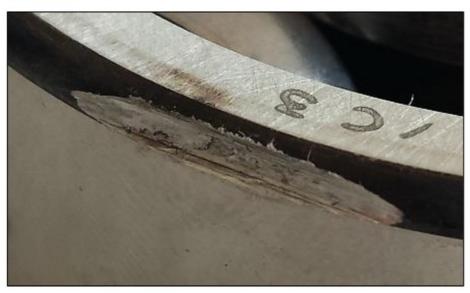
Figure 66: Bearing 1.1 clean

Figure 67: Bearing 1.1 outside of outer ring

Observing a clean bearing 1.1, a 15 mm long wear patch on the outer edge of the outside ring can be seen. When rotated, there are audible noises which would appear to be the balls moving across indentations or gouges in the race or from surface imperfections on the race. Apart from this there is minimal damage visible to the naked eye other than a few scratches and discolouration's on the faces.

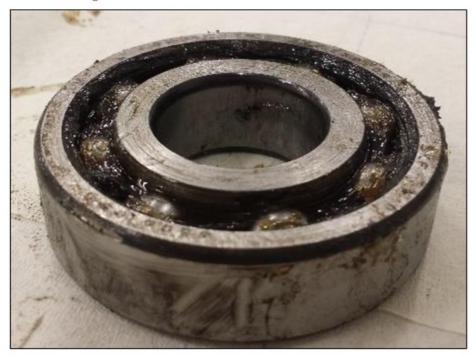
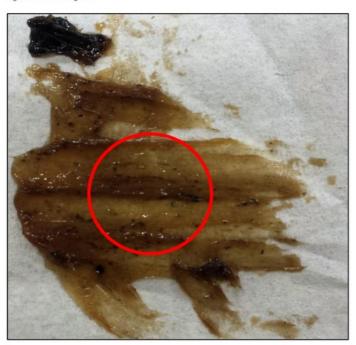
As with bearing 1.1, we can see the same black debris as well as more of the silver particles from the bearing housing and balls/races respectively. This bearing also rotates freely and smoothly.

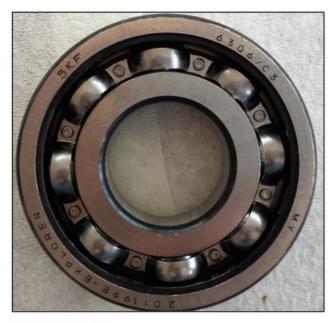
Figure 70: Bear 1.2 clean

Like bearing 1.1, bearing 1.2 also has a noisy rotation, thought to be caused by the same factors, surface imperfections and interferences. Other than this, no other damage is observed in this state.

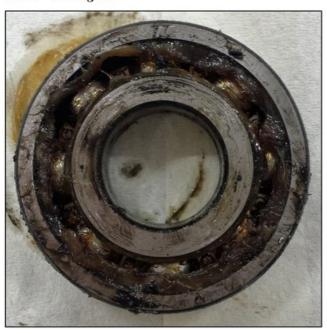
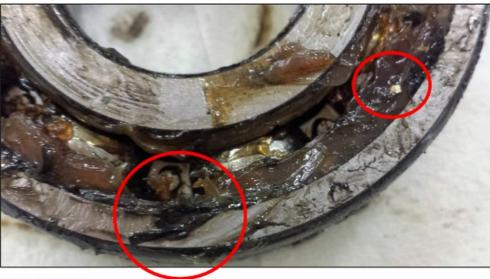
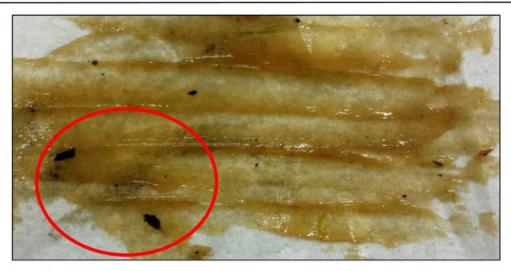
Bearing 2.1's grease is a slightly lighter colour, with a few dark areas, than the previous two bearings although it rotated smoothly and freely, with no obvious resistance. The lubrication also contains many small and large polymer particles, as well as a few small silver metal flakes.

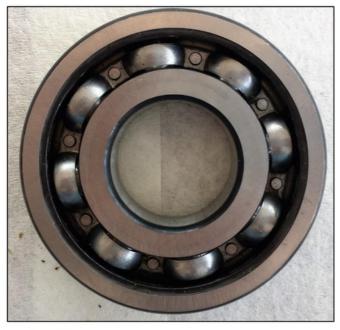
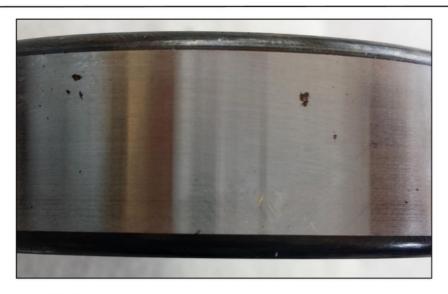
Like the previous two bearings, this bearing has the same symptoms judging from the noise level and feel when the bearing is rotated. The only other imperfections visible are on the outer surface of the outer race, small to medium specs of dirt which are stuck to the surface.

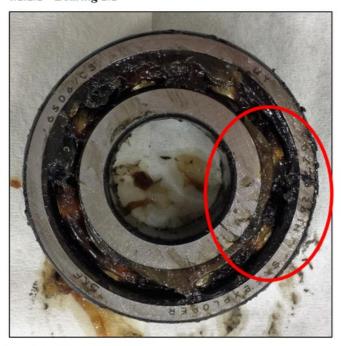
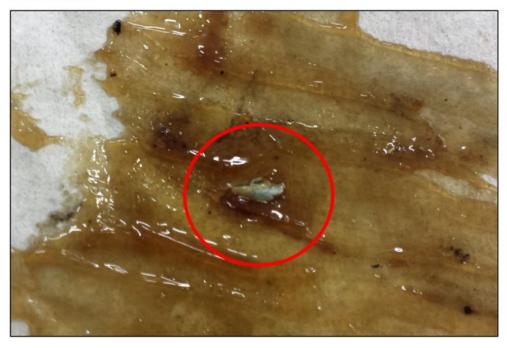
The lubricant in this bearing was a dark brown with small black polymer particles common throughout the grease along with minor amount of silver metal particles including a large flake of metal. The bearing still rotated freely and smoothly.

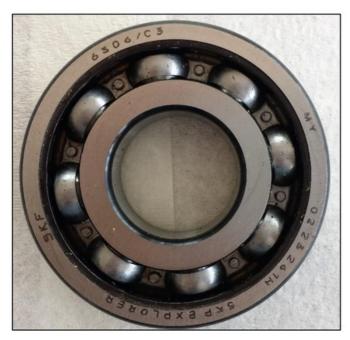
Figure 78: Bearing 2.2 clean

Similarly, to bearing 2.1, bearing 2.2 has no visible damage apart from a series of lines on the outer face (shown above in figure 79) varying in size from 5 mm to 10 mm long with the same width, 1 mm. These lines cover roughly 50% of the circumference. At a few points during spinning there was a large resistance to rotation, clearly proving there are inferences in the race of balls.

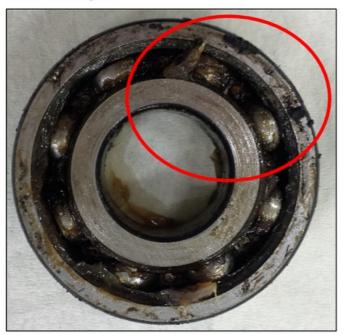
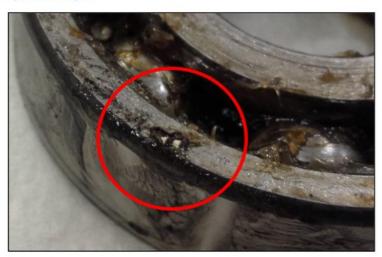
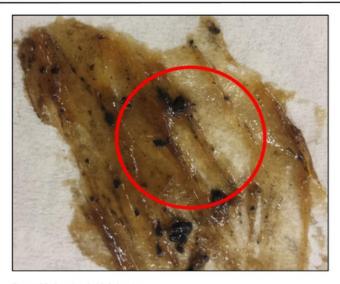
Bearing 3.1 required a little more force to rotate it but the action was smooth. There was a lack of lubricant in this bearing with multiple large black polymer particles inside and stuck to the various surfaces. There were two large silver metal flakes on the outer ring of the bearing as shown in figure 81 along with the same small black polymer particles throughout the grease.

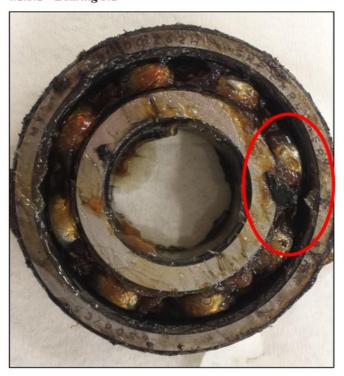
Figure 84: Bearing 3.2

Bearing 3.2 also had a lack of lubricant as with 3.1 and had multiple large black polymer particles common throughout the grease. The lubricant had leaked out to the edges bringing with it small metal flakes and small black particles. The bearing rotates freely but grinding/crunching was audible at various points around the bearing.

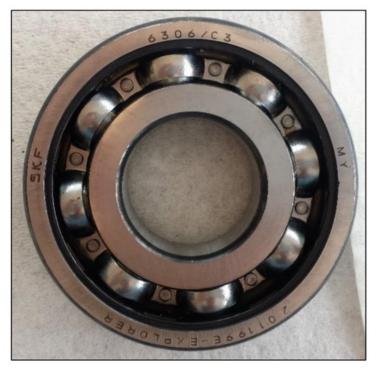
Figure 86: Bearing 3.2 clean

As with bearing 3.1, bearing 3.2 also has a large resistance to rotation, expected as they are both from the same idler roller, with relatively quiet noises coming from inside the bearing due to imperfections. Figure 87 above shows a small (1 mm) chip on the inner edge of the outer ring. In Figure 88 small scuffs can be observed on the outer edge of the outer ring.

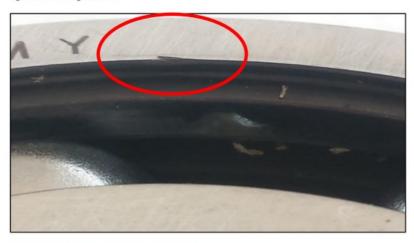
Figure 87: Bearing 3.2, inner edge of outer ring

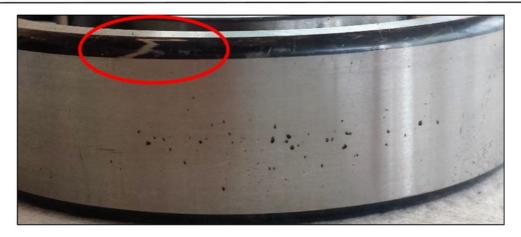
Figure 88: Bearing 3.2 outer ring face

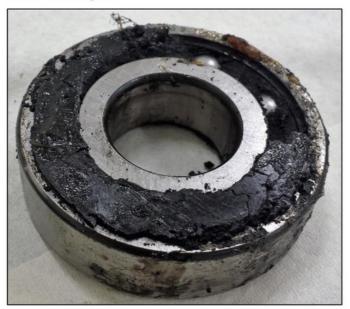
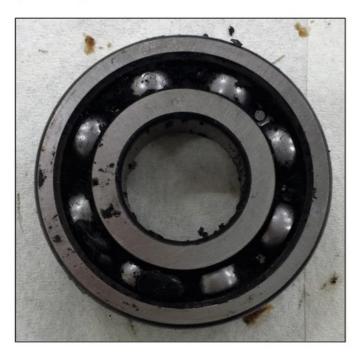
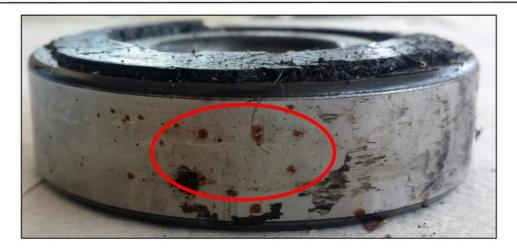
This bearing is completely seized with no rotation possible. The polymer bearing housing has melted into the bearing internals as well as the outside of the outer ring, taking the place of the lubrication, restricting movement in either direction. Small orange splotches on the outer face (roughly 0.5 mm to 2 mm in diameter) are common.

As discussed earlier in "Surface Contamination" the higher heat takes its toll on the bearing housing, giving way to polymer particles to melt onto the race. A severe example of this can be seen in figures 89 and 92 where a large amount of the rubber bearing housing has melted into the bearing itself, seizing it and rendering it useless.

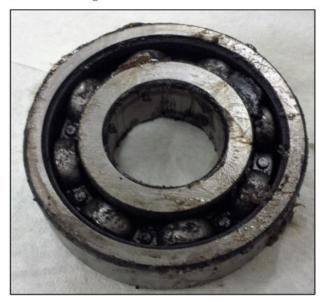
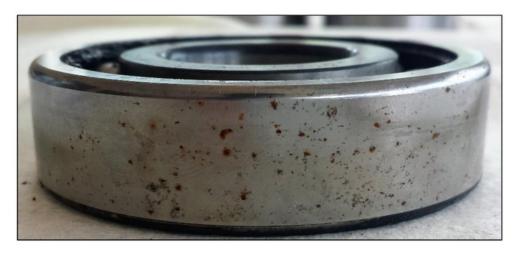
The same result as bearing 4.1, the rubber polymer bearing housing has melted into the bearing rand seized it, although allowing approximately 20° of rotation. There was a miniscule amount of lubrication inside the bearing as shown in figure 92. As with the previous bearing on the same roller the same orange splotches are found on the outer rings surface.

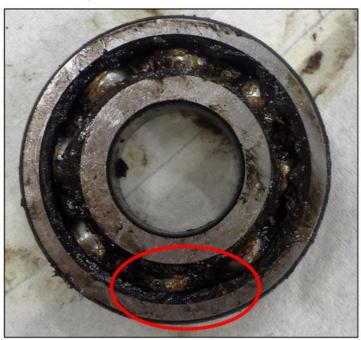
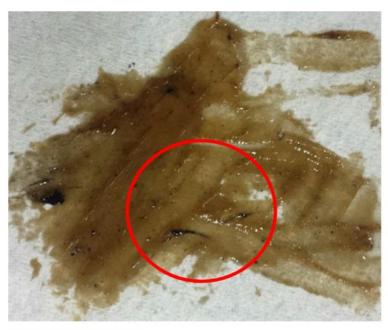
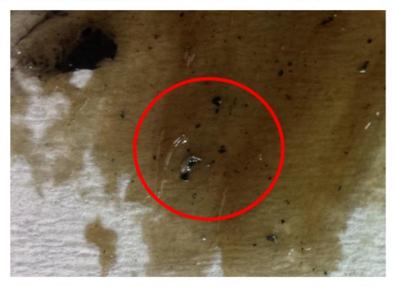
Bearing 5.1 also rotated smoothly prior to cleaning, although at first try some crunching was heard but disappeared after repeated rotation. Lubricant filled roughly 70% of the bearing and contained a few large particles of black rubber polymer (approximately 4x2x1mm) as well as some small metal particles. These can be seen in figures 95 and 96.

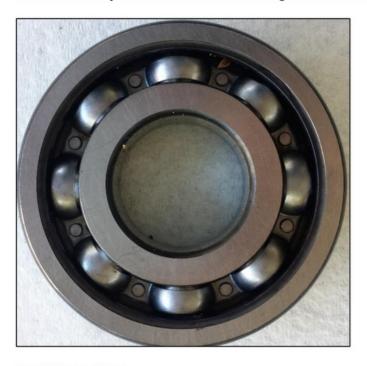
Figure 97: Bearing 5.1 clean

Bearing 5.1 has low resistance to rotation and is quiet when spinning, although some imperfections on the race mean there are audible noises during rotation. On the outer rings face, large discolourations all the way around the bearing are visible as shown above in figure 98.

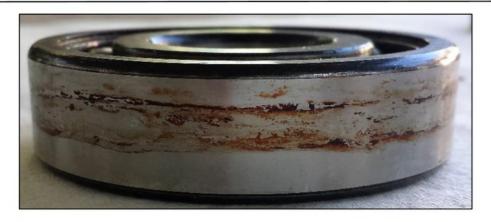
Figure 98: Bearing 5.1 outer ring face

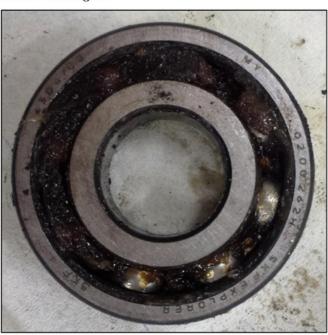
Figure 99: Bearing 5.2

There was a lack of lubricant in bearing 5.2 for roughly one quarter of the bearing and was chunky, as if stuck together in clumps. It rotated smoothly with no audible crunching or grinding and very few polymer debris nor were metal particles visible. However, the debris found was predominantly on the larger side.

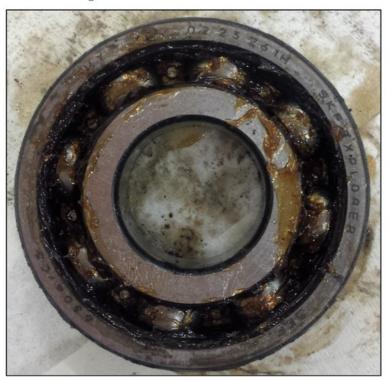
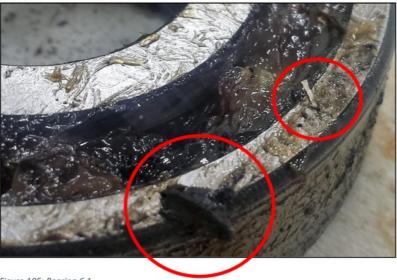
Bearing 6.1 also rotated smoothly while grease was still contained, albeit roughly 60% of lubricant remaining. There were 2 long thin strands of metal (7 mm long and much less than a fifth of a millimetre in diameter) on the edges of the outer rings race. As with the previous bearings the same small and large polymer particles and small metal particles were found within the grease.

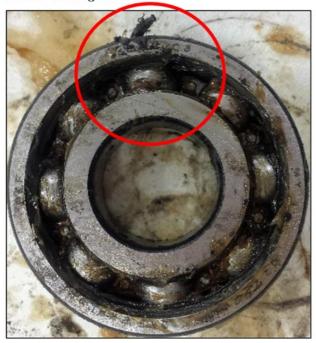
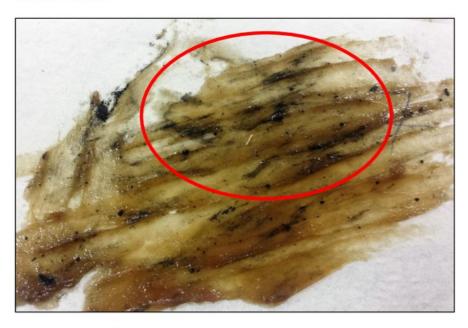
This bearing had by far the dirtiest lubrication of all bearings. 6.2's grease was filled with fine polymer particles as well as a small number of metal flakes. The bearing rotated smoothly except for slight grinding in one area.

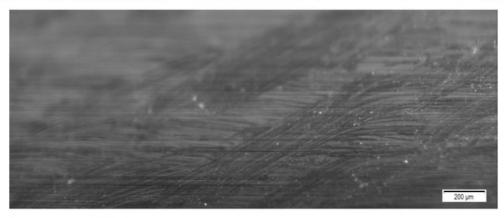
Figure 115: Bearing 2.2 outer race scratches

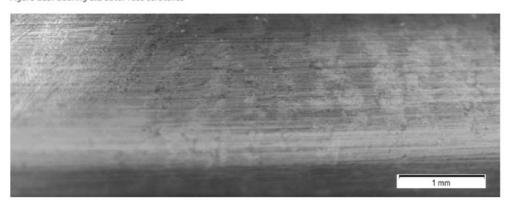
Figure 116: Bearing 2.1 outer race

Surface damage as depicted in figure 113 through to figure 125 all show surface damage in the form of scratches. This is the first stage of three body abrasion as material has not been removed at this point. As explained earlier in this document a particle, whether it be dirt, dust, bearing metal, polymer particles from the bearing housing come between the contact points, in this case the ball and either inside or outside race. Under load and rotation, the particle scratches the two surfaces. Taking figure 118 (the outer race of bearing 3.2) and figure 159 (the ball surface of the same bearing, 3.2) we can see scratches on both surfaces. This would suggest that a third body has become stuck between the two components and as the two bodies are moving against each other the particle causes the surfaces to be scratched. More examples of surface scratches can be seen in figures 113 to 125.

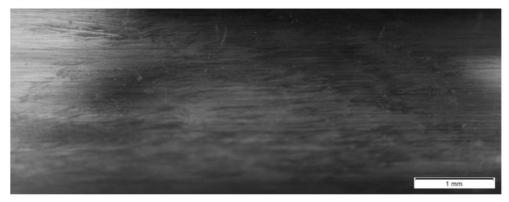
Figure 117: Bearing 3.1 inner race scratches

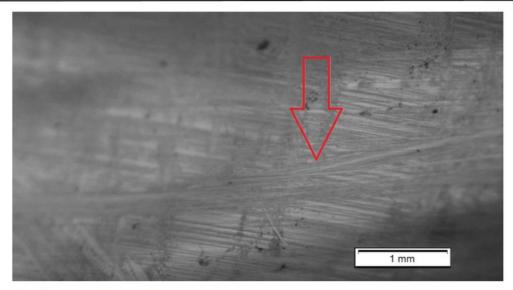
Figure 118: Bearing 3.2 outer race scratches

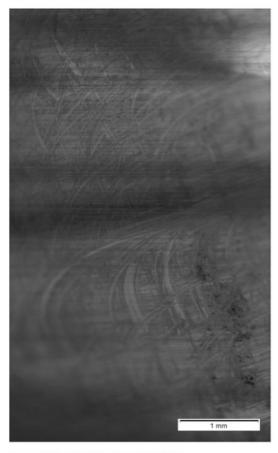
Figure 119: Bearing 3.2 outer race scratches

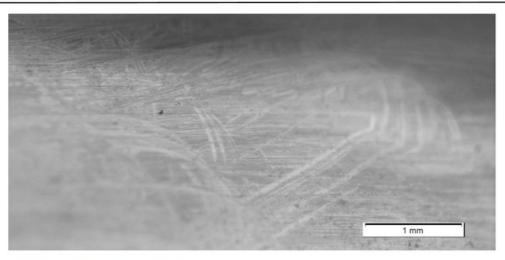
Figure 120: Bearing 4.2 outer race scratches

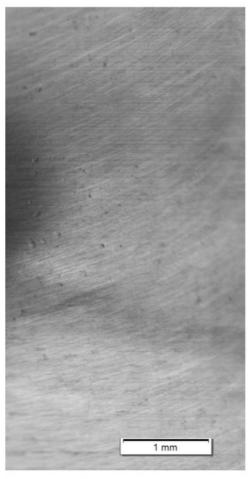
Figure 121: Bearing 5.1 inner race scratches

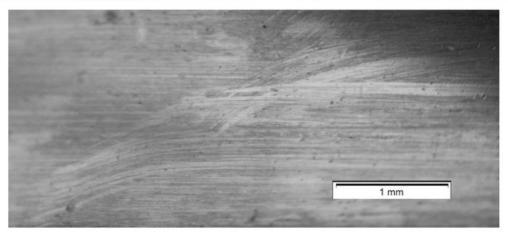
Figure 122: Bearing 5.2 inner race scratches

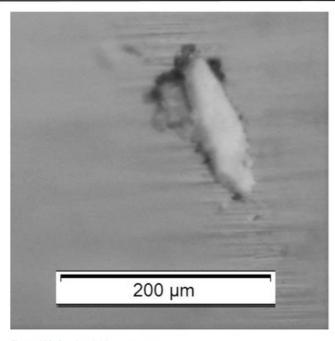
Gouges and deep scratches are the result of three body abrasion and are the next stage on from surface scratches. These were also found on the inner and outer races of multiple bearings in multiple places, making them relatively common.

Figure 128: Bearing 4.1 inner race gouge

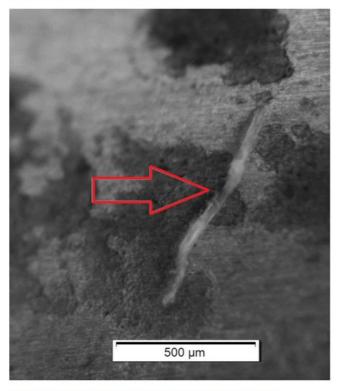
Figure 129: Bearing 4.2 outer race gouge and surface contamination

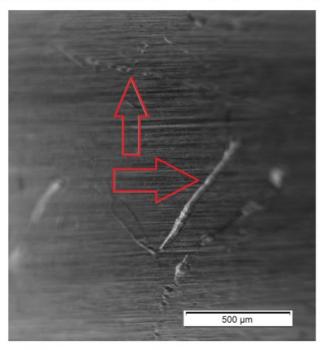
Figure 130: Bearing 5.1 outer race gouges and pitting

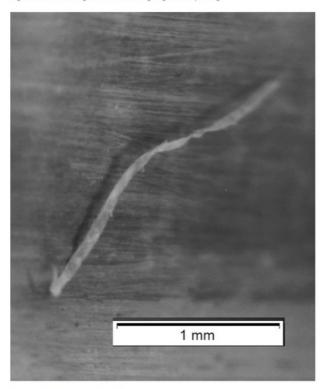
Figure 131: Bearing 5.2 inner race gouge

For such a linear gouge to form there can only be one rotating body and it must be the race. If the ball was free to rotate on any axis the groove would be look something like what can be seen in figure 131. For the groove to form the ball is seized, most likely due to a particle lodging itself in between the cage and the ball (location signified by the red 'x' in figure 168) This initial three body abrasion is now two body abrasion, with the seized ball and particle acting as the cutting tool. During this process, there is a large amount of material removal and plastic deformation like that of three body abrasion.

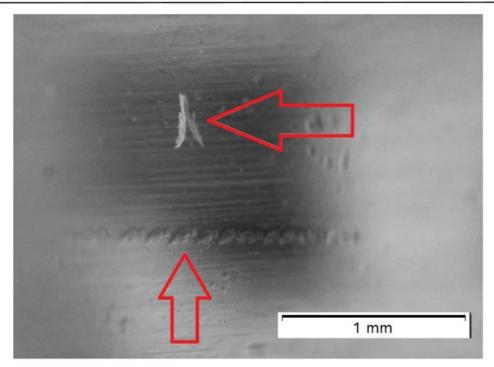
Figure 137: Bearing 3.1 inner race bruising

The result of pitting is an indentation in the surface of the race or ball. Examples can be found in every bearing showing that it is a common problem with premature failure of bearings used on mine sites. Figures 136 to 142 are all examples of pitting or bruising to the inner or outer race. The shape of the pits are generally similar to that of the particle that caused it.

Looking at figure 137 the inside race, the lower red arrow points to a series of bruises in a linear path, each the same shape indent. This would suggest the same particle has created these in quick succession. The damage is roughly 1 mm long with each pit approximately 83.3 microns in width. The particle must be extremely resistant to deformation and not brittle in any way to consistently create the same profile pits. The suspected method of pit formation of this type is a hard particle become lodged or stuck to the ball. At high speeds and under high loads, as the part of the ball with the particle rotates on the race it indents the surface. This is similar to how a groove is formed but in this case the ball is not seized and free to rotate. The same mode of damage can be seen in figure 140.

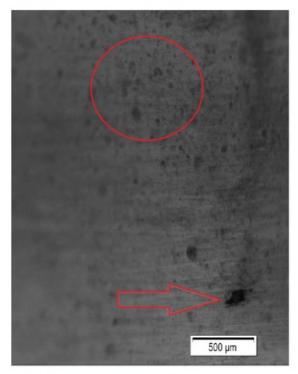
Figure 138: Bearing 4.1 outer race pitting

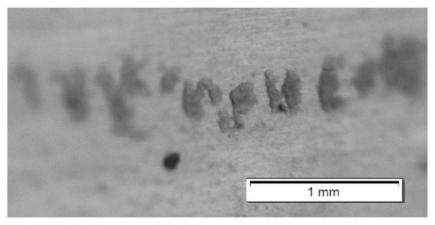
Figure 140: Bearing 4.2 inner race series of chips

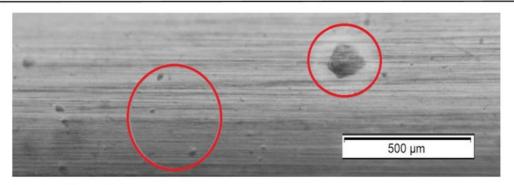
Figure 141: Bearing 5.1 outer race bruising

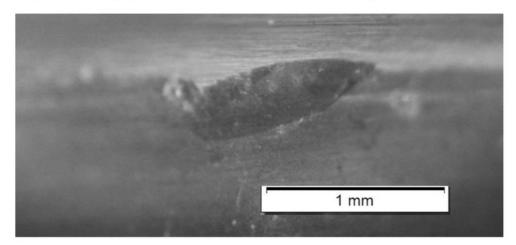
Chips like those shown in figure 150 were not too common during for the bearings used in this project. This example, as well as 3 others, were all located on the edges of the outer races.

Figure 148: Bearing 6.1 outer race chip on edge

Chips like that shown in figure 148 were not a common appearance in the bearings studied. A chip like this has no signs of wear in the close vicinity, suggesting that it was not caused by three body abrasion or another form of wear. The chip in figure 148 was similar to other chips in 2 other bearings in both location and size, approximately 1 mm in length.

There is little or no force or stress subjected to the edge on the races meaning that this damage could not have occurred during the operation of the bearing. In "Literature Review" -> "Bearing Damage Analysis" -> "Installation", it was said that it was common for damage to take place during installation or transportation of the idler roller. A roller can be dropped, knocked around or installed using improper tools which can lead to a chip like in figure 148 being created.

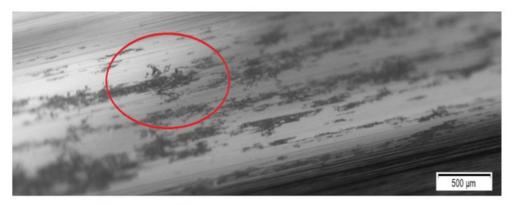
Figure 149: Bearing 1.2 outer race surface contamination

From figure 149 to figure 153, we can see that the surfaces of the bearing race are not affected much by three body abrasion and have no pits, spalling or gouges in them. The main issue here is the surface being covered by foreign material, with a higher friction coefficient than bearing metal. As the material is stuck to the race, it adds a small layer of thickness to the race, resulting in a slightly tighter fit for the ball to travel past (between the inner and outer races) meaning more friction and therefore more heat. An added issue of a different surface is that the lubrication was not designed to be in contact with other material. It is no longer possible for a thin film to be formed over the contaminated surface, also increasing the friction.

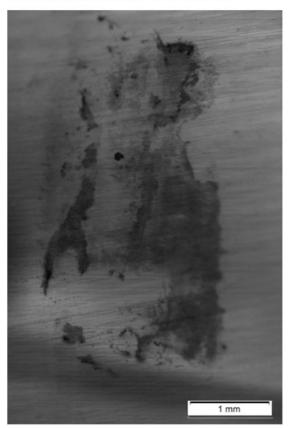
Figure 150: Bearing 2.2 inner race surface contamination by polymer of bearing housing

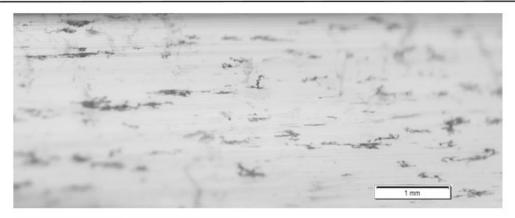
Figure 151: Bearing 5.1 outer race surface contamination

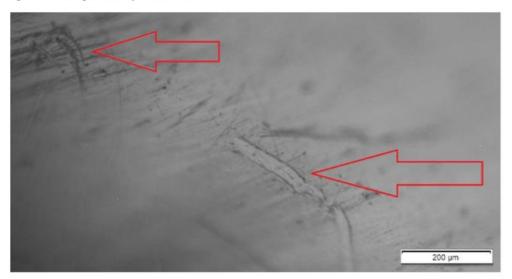
This section specifically looks at the damage to the balls of the bearing. The wear is a mix of surface scratches, gouges, pitting and bruising as well as surface contamination. All of which a result of third body abrasion, bar surface contaminations in figure 164 highlighted by the red circle.

Figure 157: Bearing 2.2 ball surface scratches and pitting

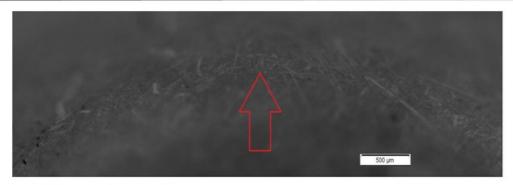
Figure 158: Bearing 3.1 ball surface scratches

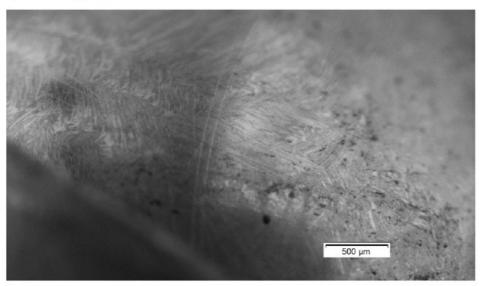
Figure 162: Bearing 5.2 ball scratches and pitting

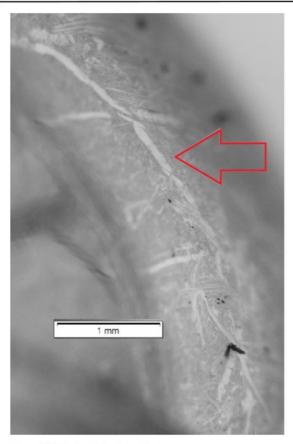
Figure 163: Bearing 6.1 ball scratches

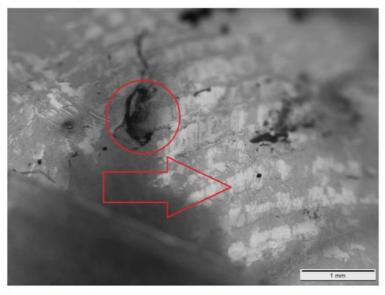
Figure 164: Bearing 6.2 ball scratches (arrow) and surface contamination (red circle)

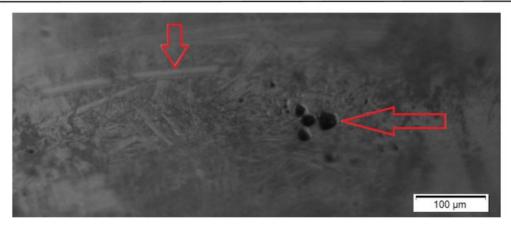
Figure 165: Bearing 2.1 ball scratches and pitting

In some areas of the balls surface there are pits that would have been formed by hard particle indentation. Figures 165, 166 and 167 highlight the pits in the surface. The red arrow on the right in figure 165 points to large holes in the surface in which hard particles would be lodged.

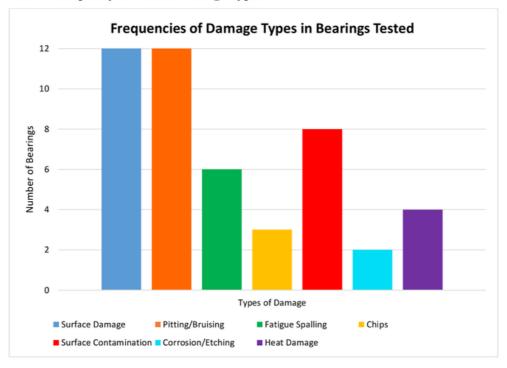
Figure 176: Frequency of various damage types

The graph above displays how common each type of damage is relative to the others. We can see that "Surface Damage" and "Pitting/Bruising" occurred in all twelve bearings meaning that three body abrasion is a common root cause of failure. Fatigue spalling is also a result of three body abrasion but is a more severe form and so is less common. Surface contamination is also common result with corrosion/etching happening only once in the batch of bearings studied.
